**SIDECAN SONAR INTERPRETATION, EVALUATION AND REGIONAL
INTEGRATION: OFFSHORE DIGBY NECK, BAY OF FUNDY**

**Gordon Fader
Atlantic Marine Geological Consulting Ltd.
2901 Parkdale Avenue
Halifax, Nova Scotia
B3L 3Z2**

March, 2005

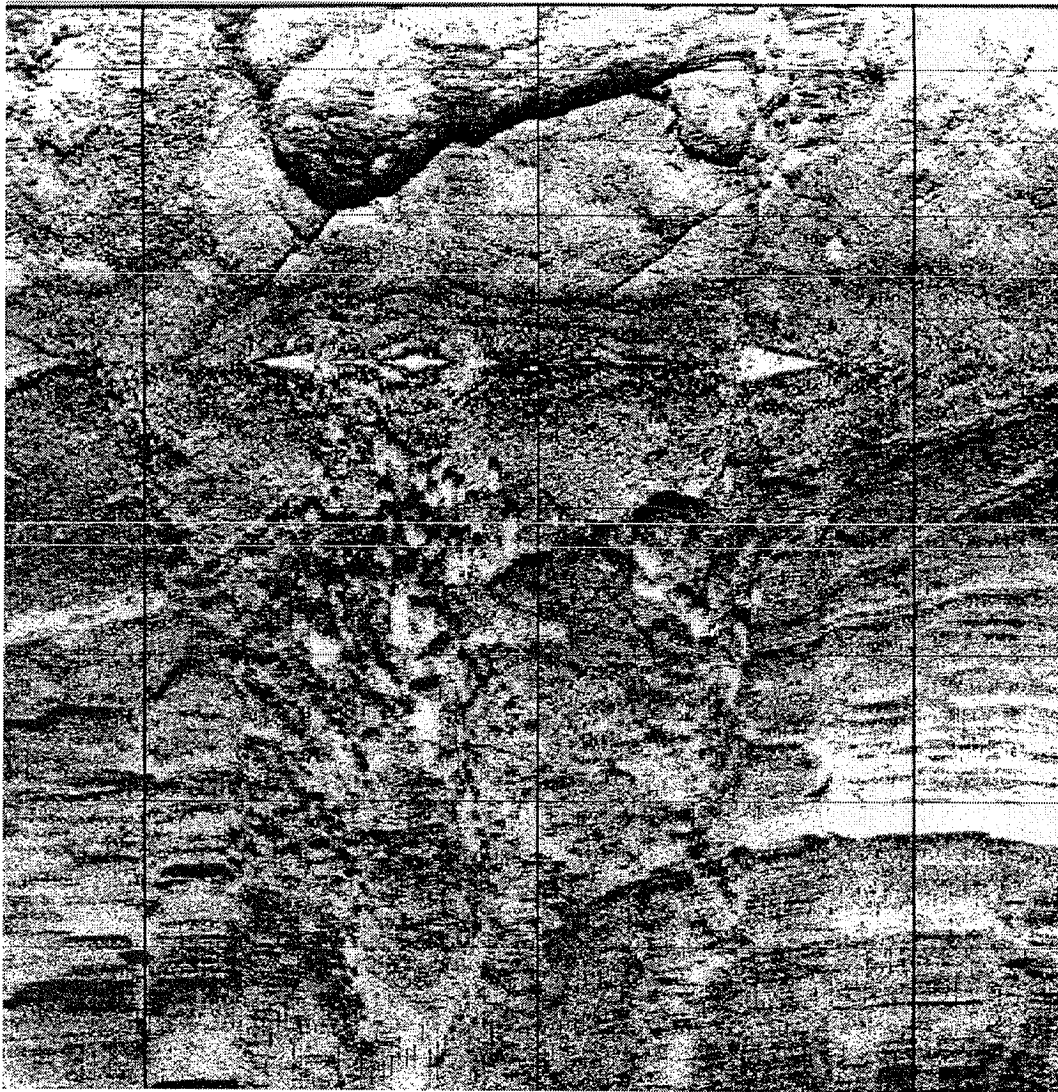
Figure 2

Figure 2. A sidescan sonogram from an area of bedrock in the nearshore off Whites Point. The seabed consists largely of exposed bedrock with boulders. Note the fractures and joints within the bedrock.

The sidescan sonar data indicate that the seabed of the area is largely bedrock outcrop. The bedrock surface is very rough and irregular and exhibits joints and fractures and areas that consist of flat lying massive slabs (Figure 2). Video transects across this surface show the presence of small local patches of coarse sand and gravel and broken and whole shells are common. Further seaward, sand overlies the bedrock and small areas of bedrock protrude through the thin sand. The sand is very coarse bordering on the fine-gravel size using the Wentworth scale. Broken shell fragments and pebbles/cobbles occur with the sand.
