Black Point Quarry Project
Municipality of the District of Guysborough, NS

Environmental Impact Statement

Vulcan Materials Company

February 2015

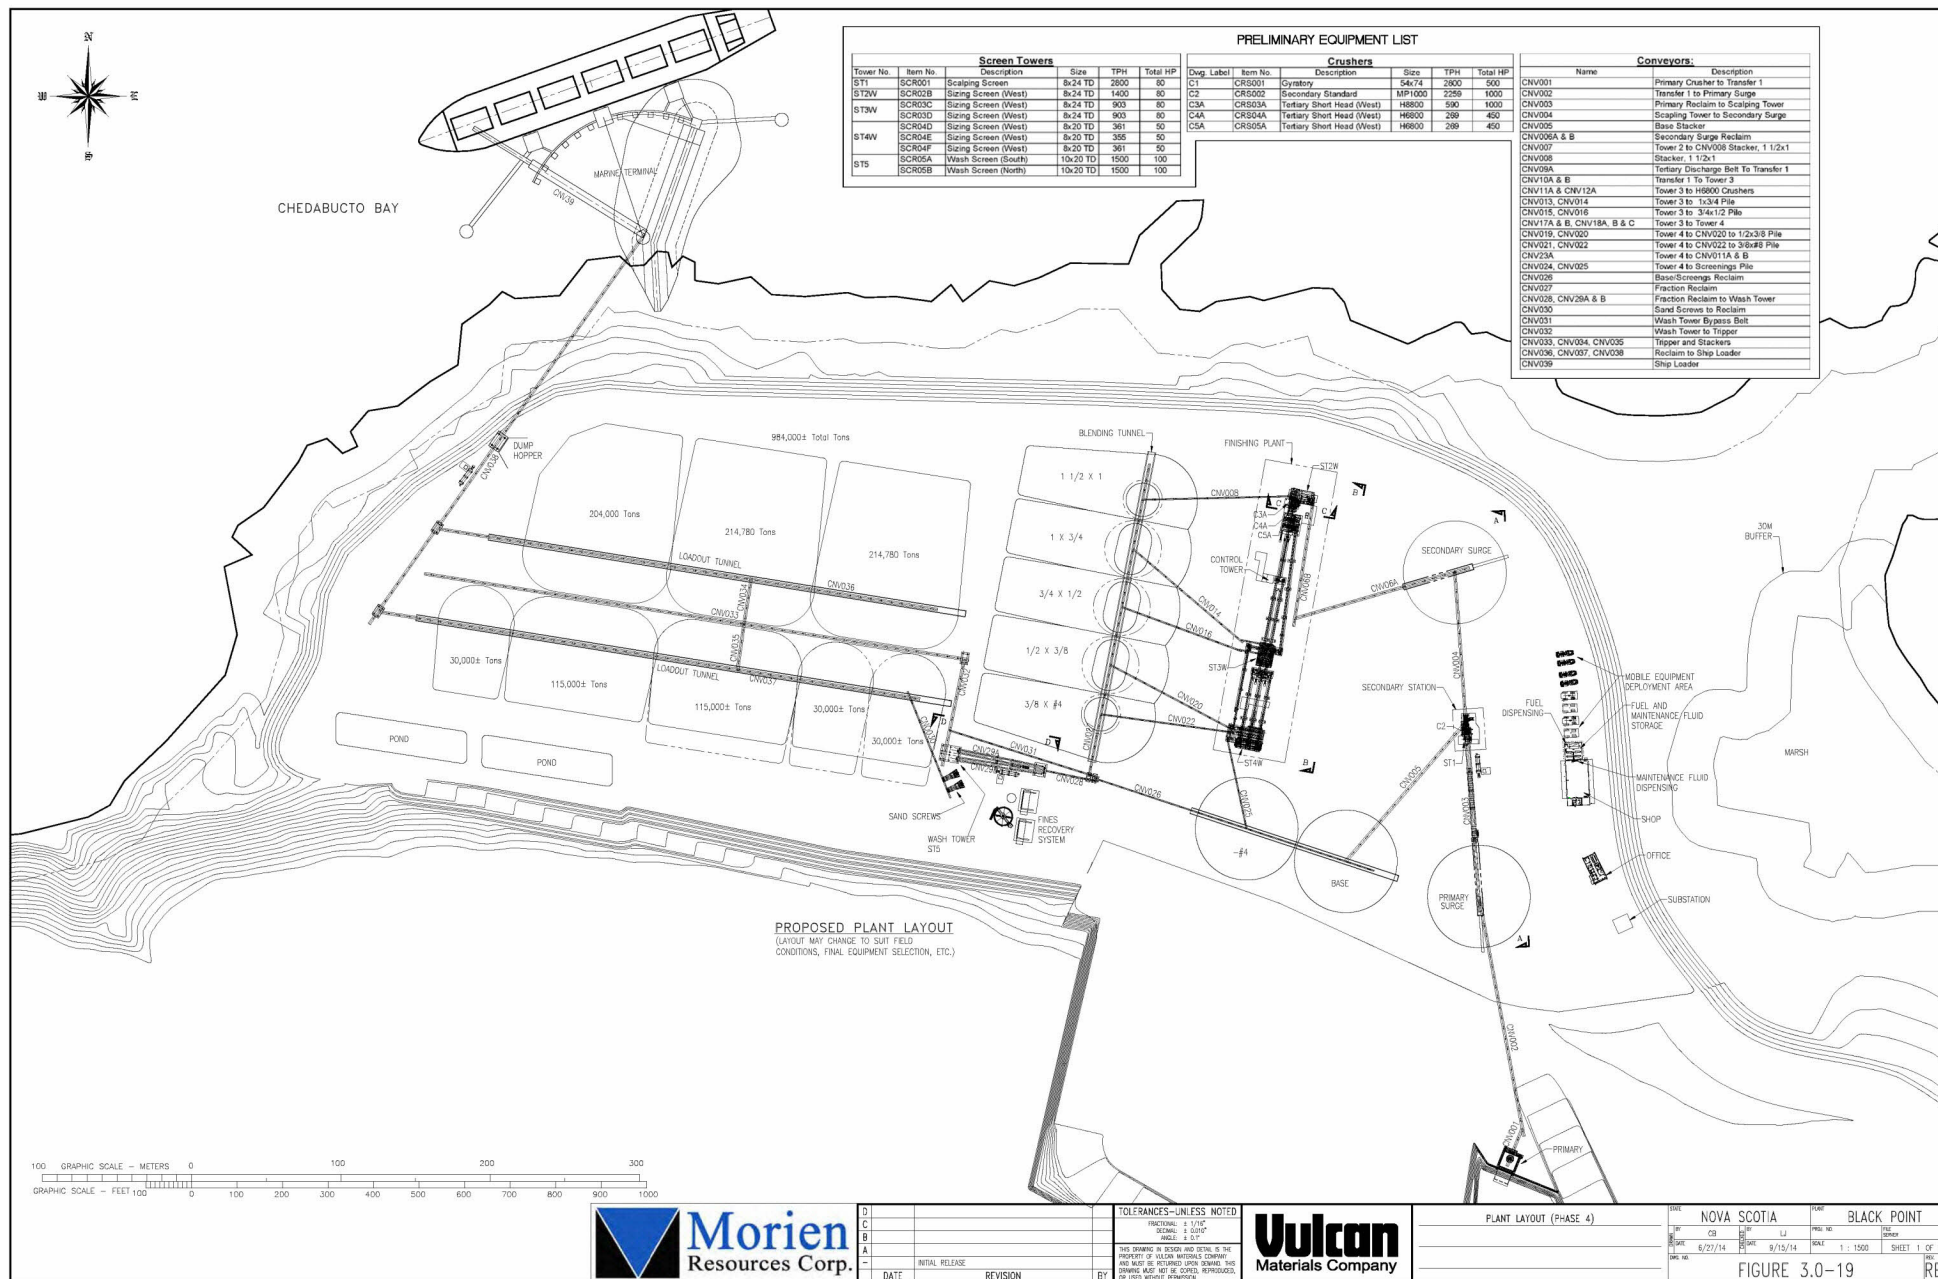
In this plant, blasted material will be trucked to the primary crusher where it will be dumped into the primary hopper. There it will be crushed and conveyed to a primary surge pile located near the “secondary” where it will be fed into the plant. As the material is processed with further crushing and screening, it will be conveyed to product piles that are located over “reclaim” tunnels, that is, tunnels equipped with conveyor systems that allow the products to be moved. Products can then be reclaimed to the wash tower for rinsing or bypassed around it. Material will then be stockpiled over the loadout reclaim tunnels that will convey product to the marine terminal.

The plant layout is designed in consideration of safe operational needs along with best practices developed over many years. The plant will be designed to minimize airborne dust emissions by utilizing built-in wet suppression for dust control. All structures will be designed according to appropriate building codes and engineering standards. Electrical power for the plant will be provided via Nova Scotia Power Inc. as described in Section 3.1.6.

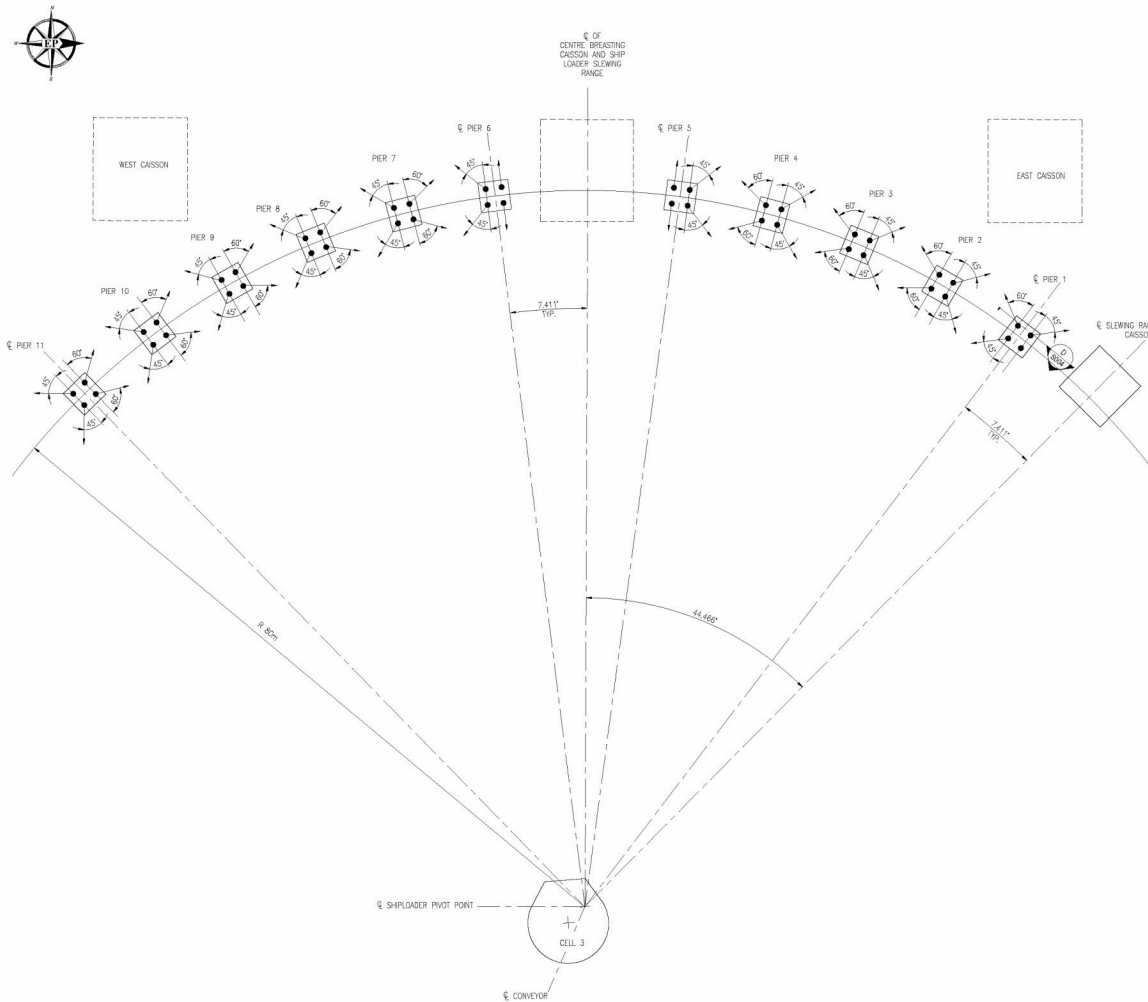
PLAN - SLEWING RAIL PIER LAYOUT

NOVA SCOTIA	BLACK POINT
DATE: 2014/06/26	DATE: 2014/06/26
BY: CHS	BY: BT
CHECKED: CHS	CHECKED: BT
APPROVED: CHS	APPROVED: BT
FIG. NO.	FIG. NO.
AS NOTED	AS NOTED
SHEET 3 OF 4	SHEET 3 OF 4
FIGURE 3.0-24	A

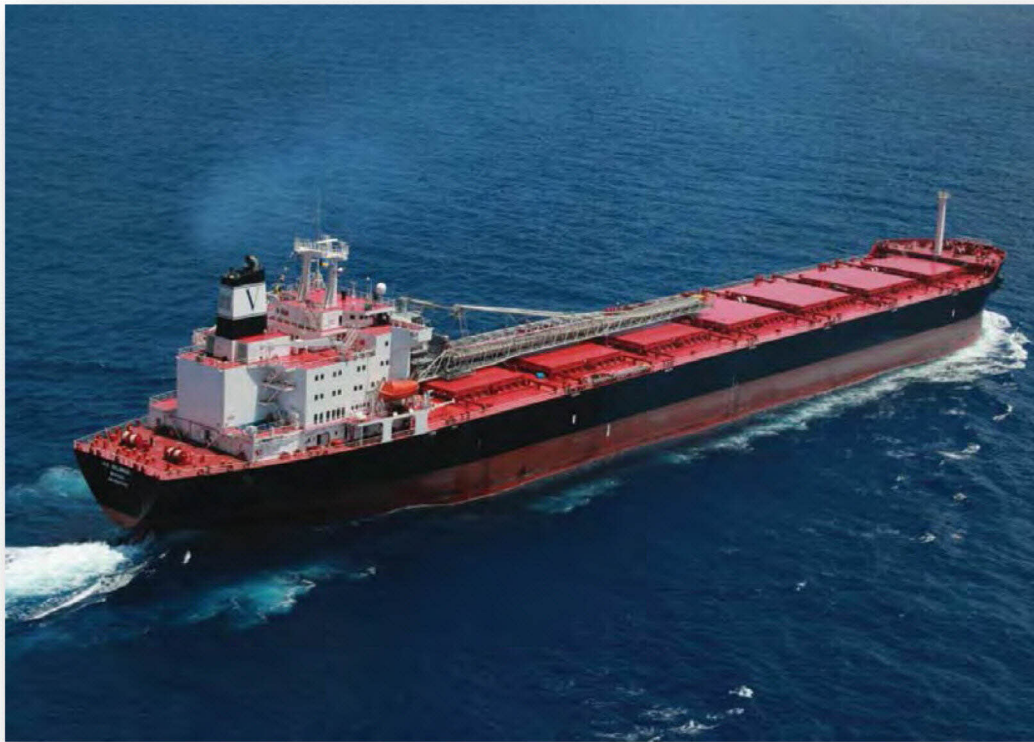
Figure 3.0-28:
“Panamax” Size Ship

The typical vessel used to transport aggregate is a 70,000 DWT “Panamax” size ship (**Figure 3.0-28**). During the initial stages of production before the plant is operating at maximum capacity, ships will arrive at the terminal on average approximately 1 to 3 times per month. As market conditions warrant, this will increase to a maximum of 1 to 2 ships per week. Ship loading typically requires 18 to 24 hours and so a typical cycle of arrival–berthing-loading-departure requires on average one to two days. Aggregate products will be the only material off-loaded at the Project site. Shipping will typically be arranged through the customers, who will arrange for ship arrival and departure at the marine terminal.

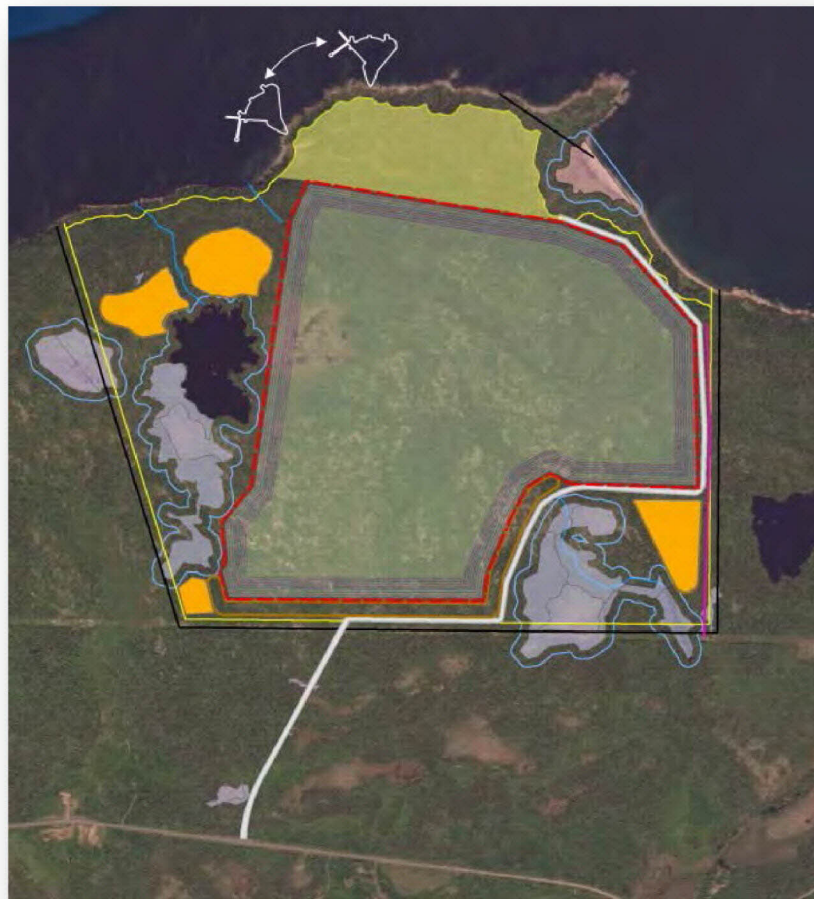
Figure 4.0-3:
Alternative Crusher Fines Storage Areas (Orange)

Initially, crusher fines storage was proposed for areas outside of the quarry (**Figure 4.0-3**) but this was later determined to be unnecessarily distant from where this crushed rock will be generated. All waste rock will now be stored within the quarry. This has the additional advantage of ensuring the crusher fines can never be lost to the marine environment.

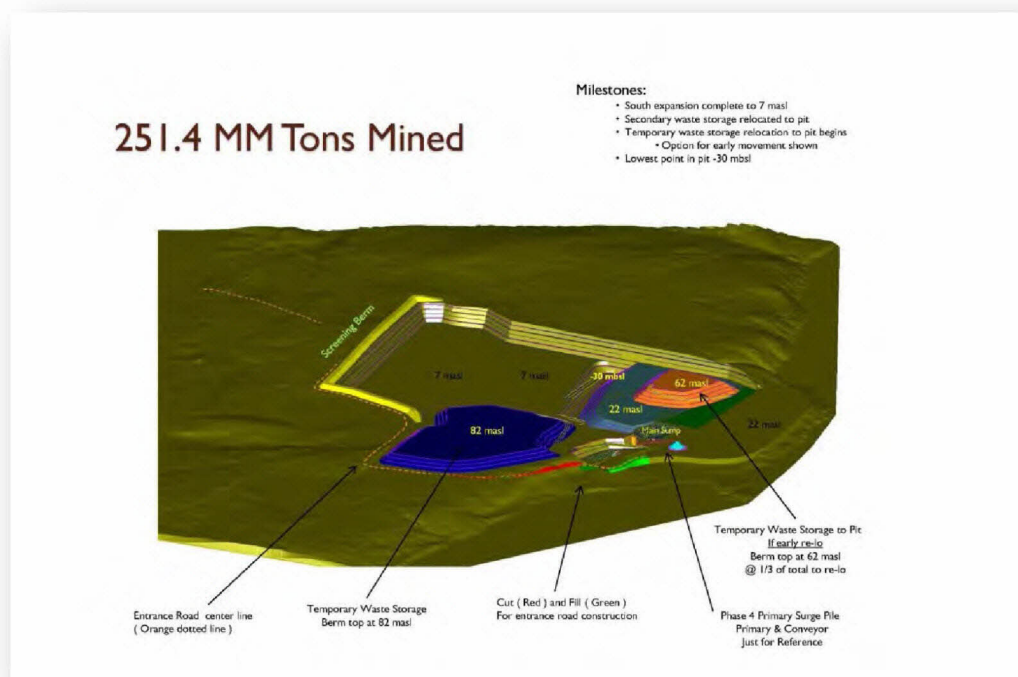
**Figure 4.0-4:
Preferred Crusher Fines Storage Areas (Orange and Blue)**

The storage of the fines inside the quarry also eliminates the potential for storm water runoff releases to the environment and the discharge of fines to surface waters because the quarry stormwater will be contained in the pit. The fines stock piles also can be sources of fugitive dust emissions and so locating them inside the quarry will help to contain these emissions.

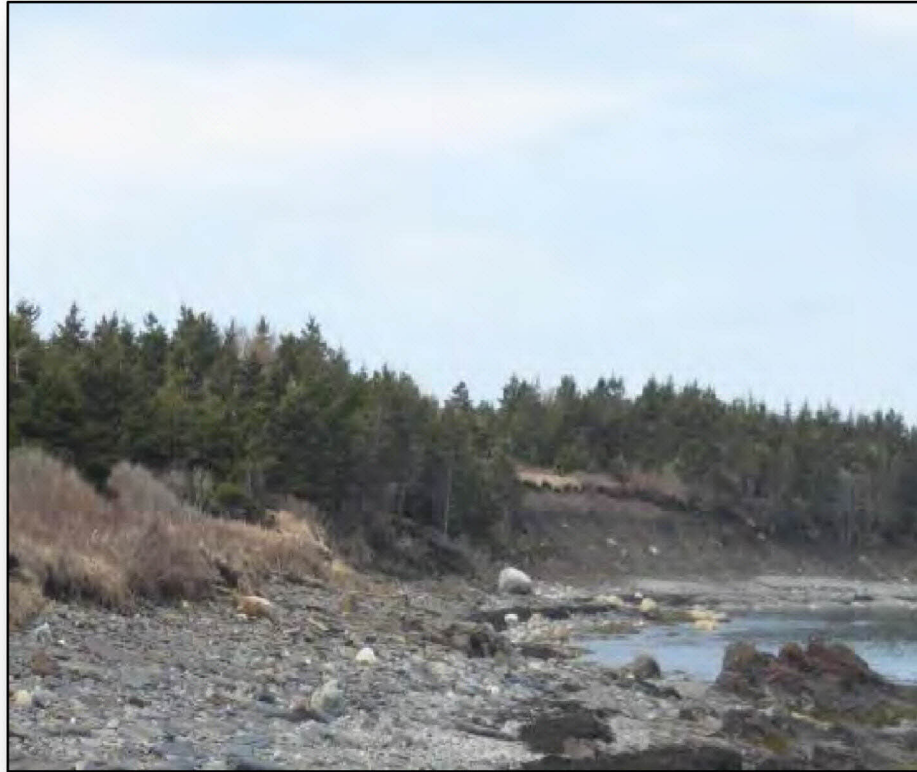
Observations made on site indicate these tills are essentially absent on the top of the granite hill, but thicken on the slopes of the hill at lower elevations. The tills are well exposed along the coastline at Half Island Cove (Figure 6.1-5) and Fox Island Main. Dug wells, which are used more often than drilled wells in this area to provide potable water, are installed in these loose tills.

Figure 6.1-5:
View of glacial till east of Gaulman Point

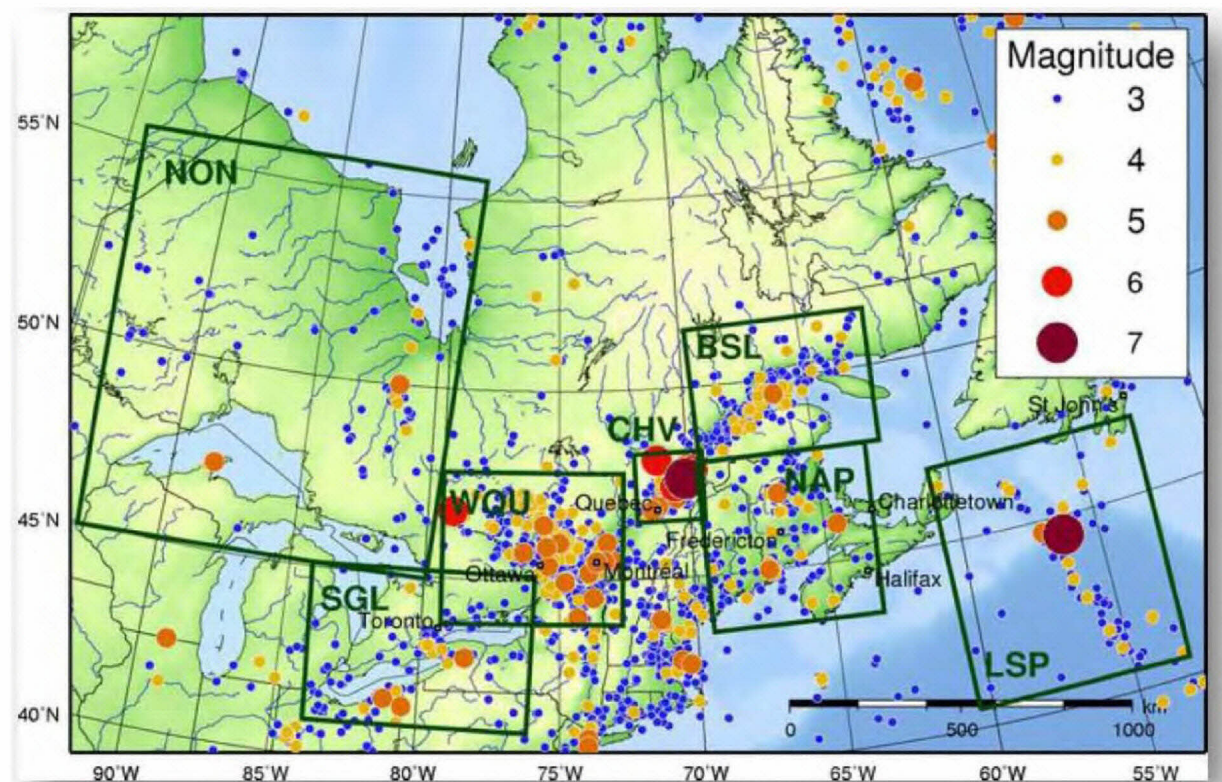
Figure 6.1-7:
Distribution and magnitude of historical earthquakes

Seismic activity may affect operations of any facility, particularly one close to the ocean where a tsunami can have consequences. Figure 6.1-7 shows the distribution and size of historical earthquakes recorded in eastern Canada, while Figure 6.1-8 shows the relative earthquake hazard across Canada. All of Nova Scotia is located within the next-to-lowest low hazard zone.

The Black Point Quarry site is located at the edge of the "minor damage" zone for the 1929 tsunami (NRCan 2013b). As indicated in Figure 6.1-7, there are no historical earthquakes reported to originate in or near Cobequid Bay. For reference, reports of the 1929 earthquake were converted to Revised Modified Mercalli Intensities (MMI) and plotted on a map (Figure 6.1-9). Canso records a MMI of 5 out of 10 (shaking: moderate; damage very slight). In summary, the Project site is located in an area of low seismic hazard.

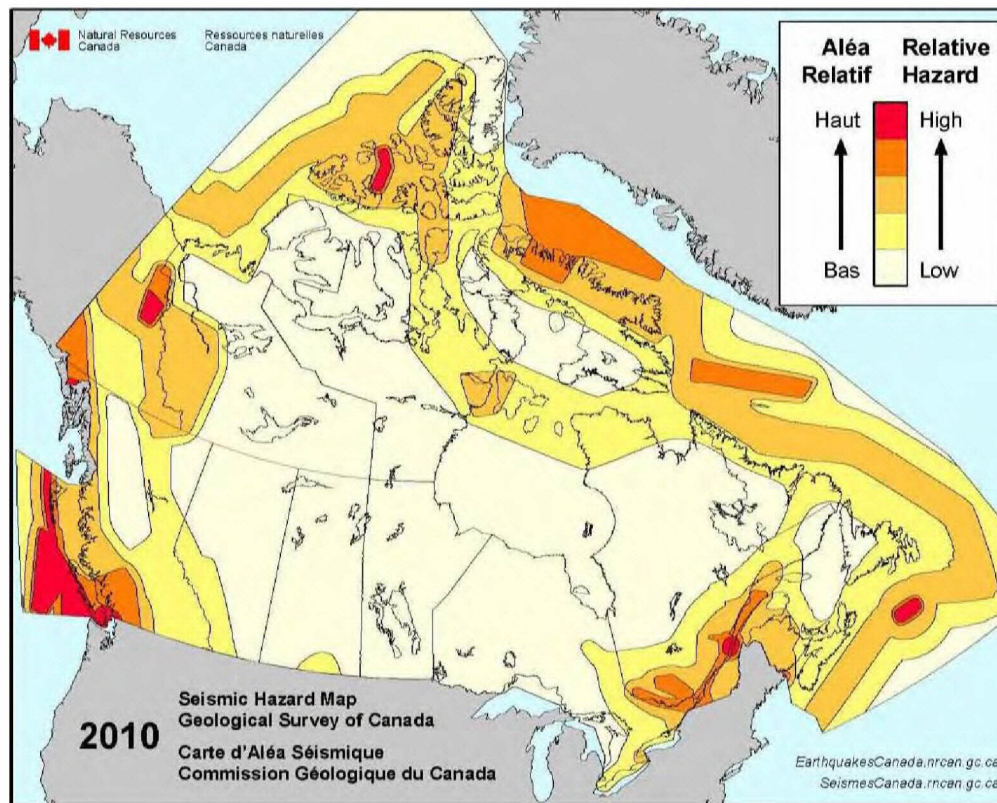
**Figure 6.1-8:
 Relative Earthquake Hazard**

The rectangles delineate larger scale maps available at Earthquakes Canada. The Laurentian Slope Seismic Zone (LSP) denotes an area off Canada's southeast coast, which includes the Grand Banks of Newfoundland. The Laurentian Slope experienced about nine events 5.0 or greater between 1929 and 1977 (Ruffman 1995). The large red dot within the LSP zone identifies the location of a magnitude 7.2 earthquake that occurred in 1929. Tragically, this earthquake caused a tsunami which killed 28 people on Newfoundland's Burin Peninsula.

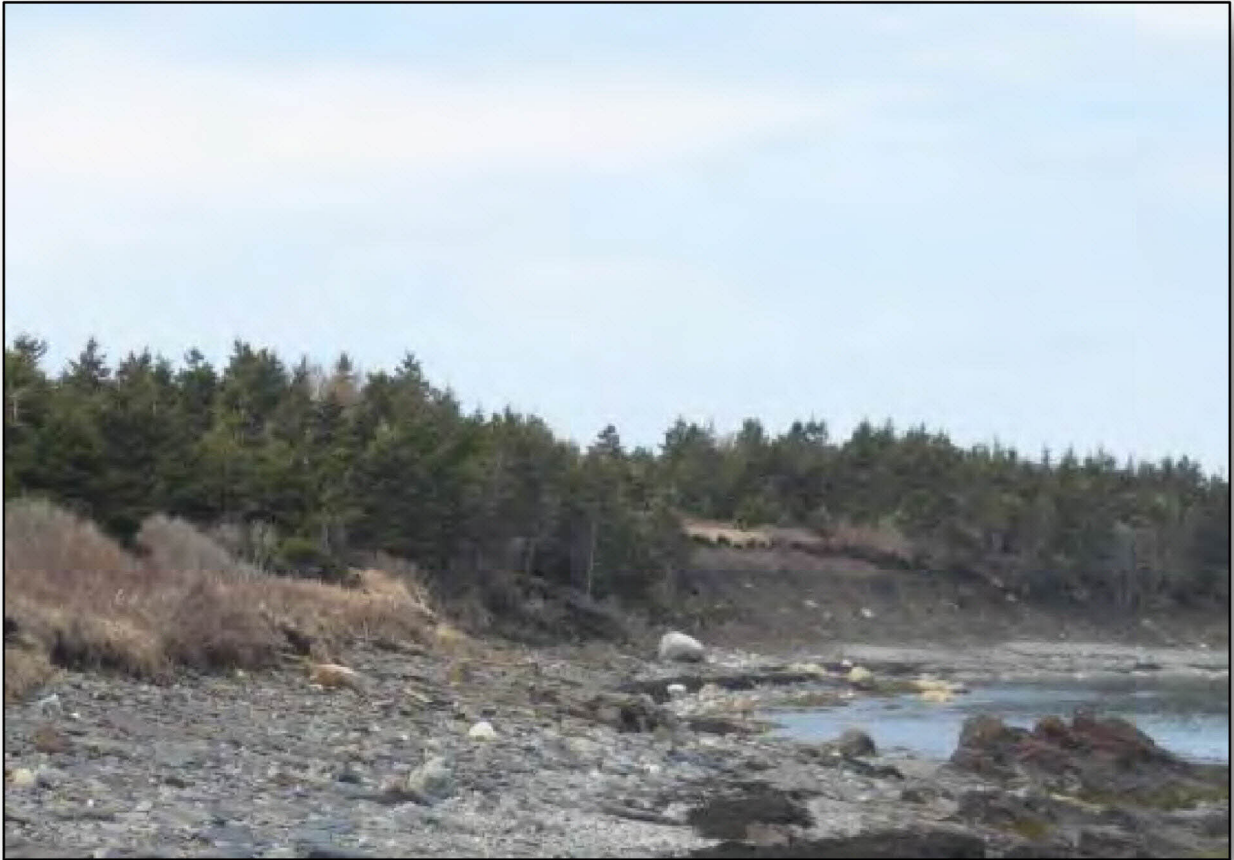
Figure 1
Photo - View from the east side of Gaulman Point looking at glacial tills.

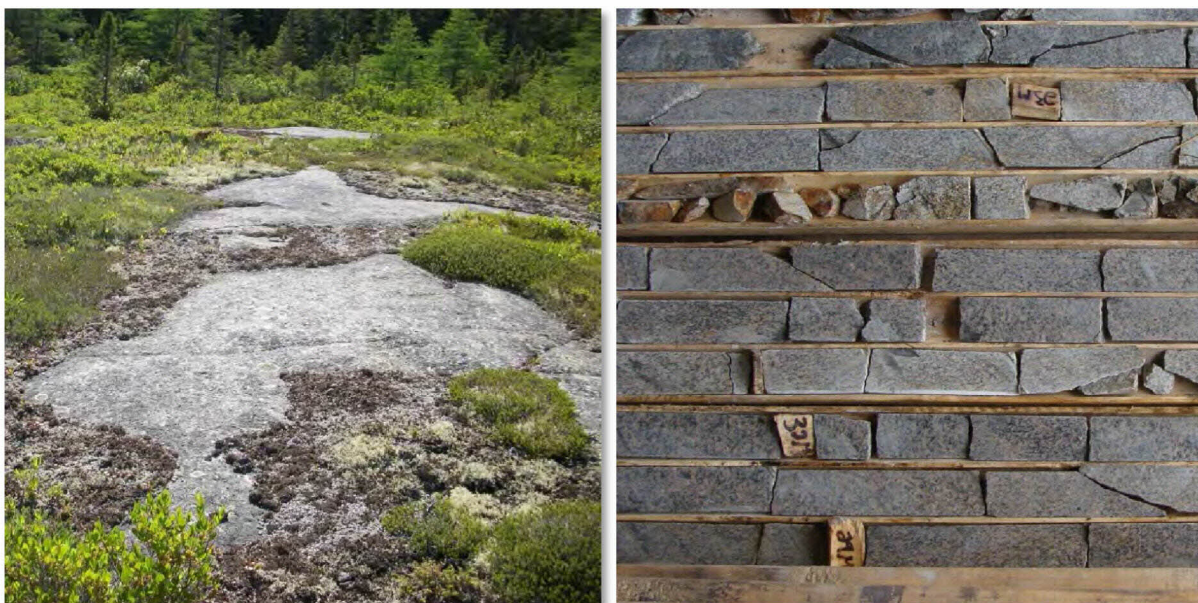
Figure 4
Photo - Outcrop of granite (left) and core detail in closeup (right).

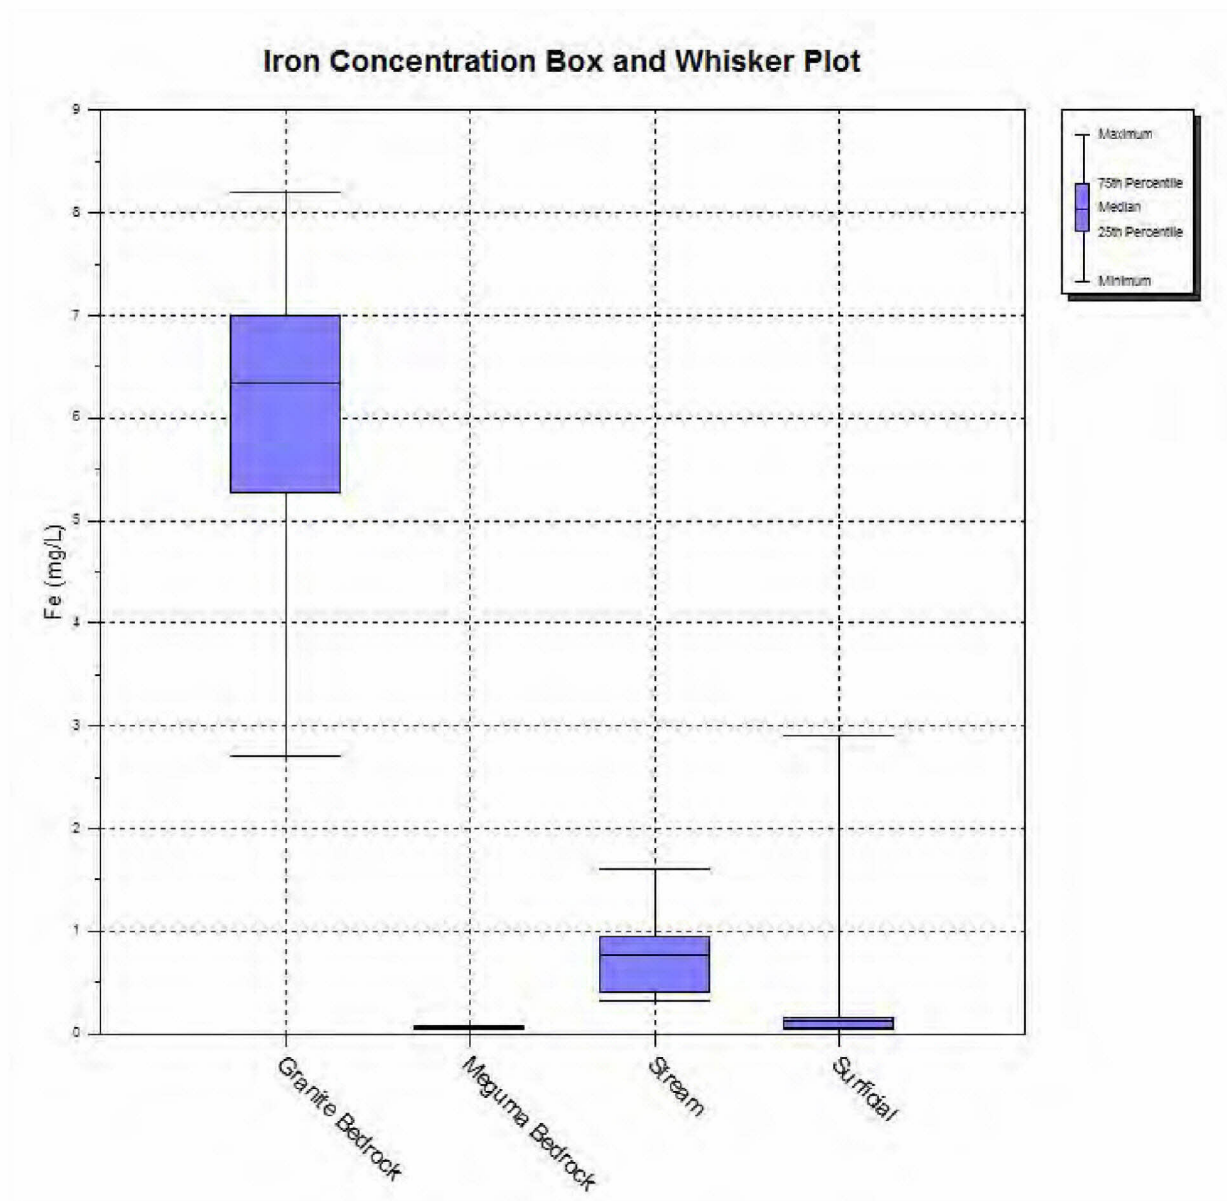
Figure 7
Box and Whisker Plot of Iron in Groundwater and Surface Water

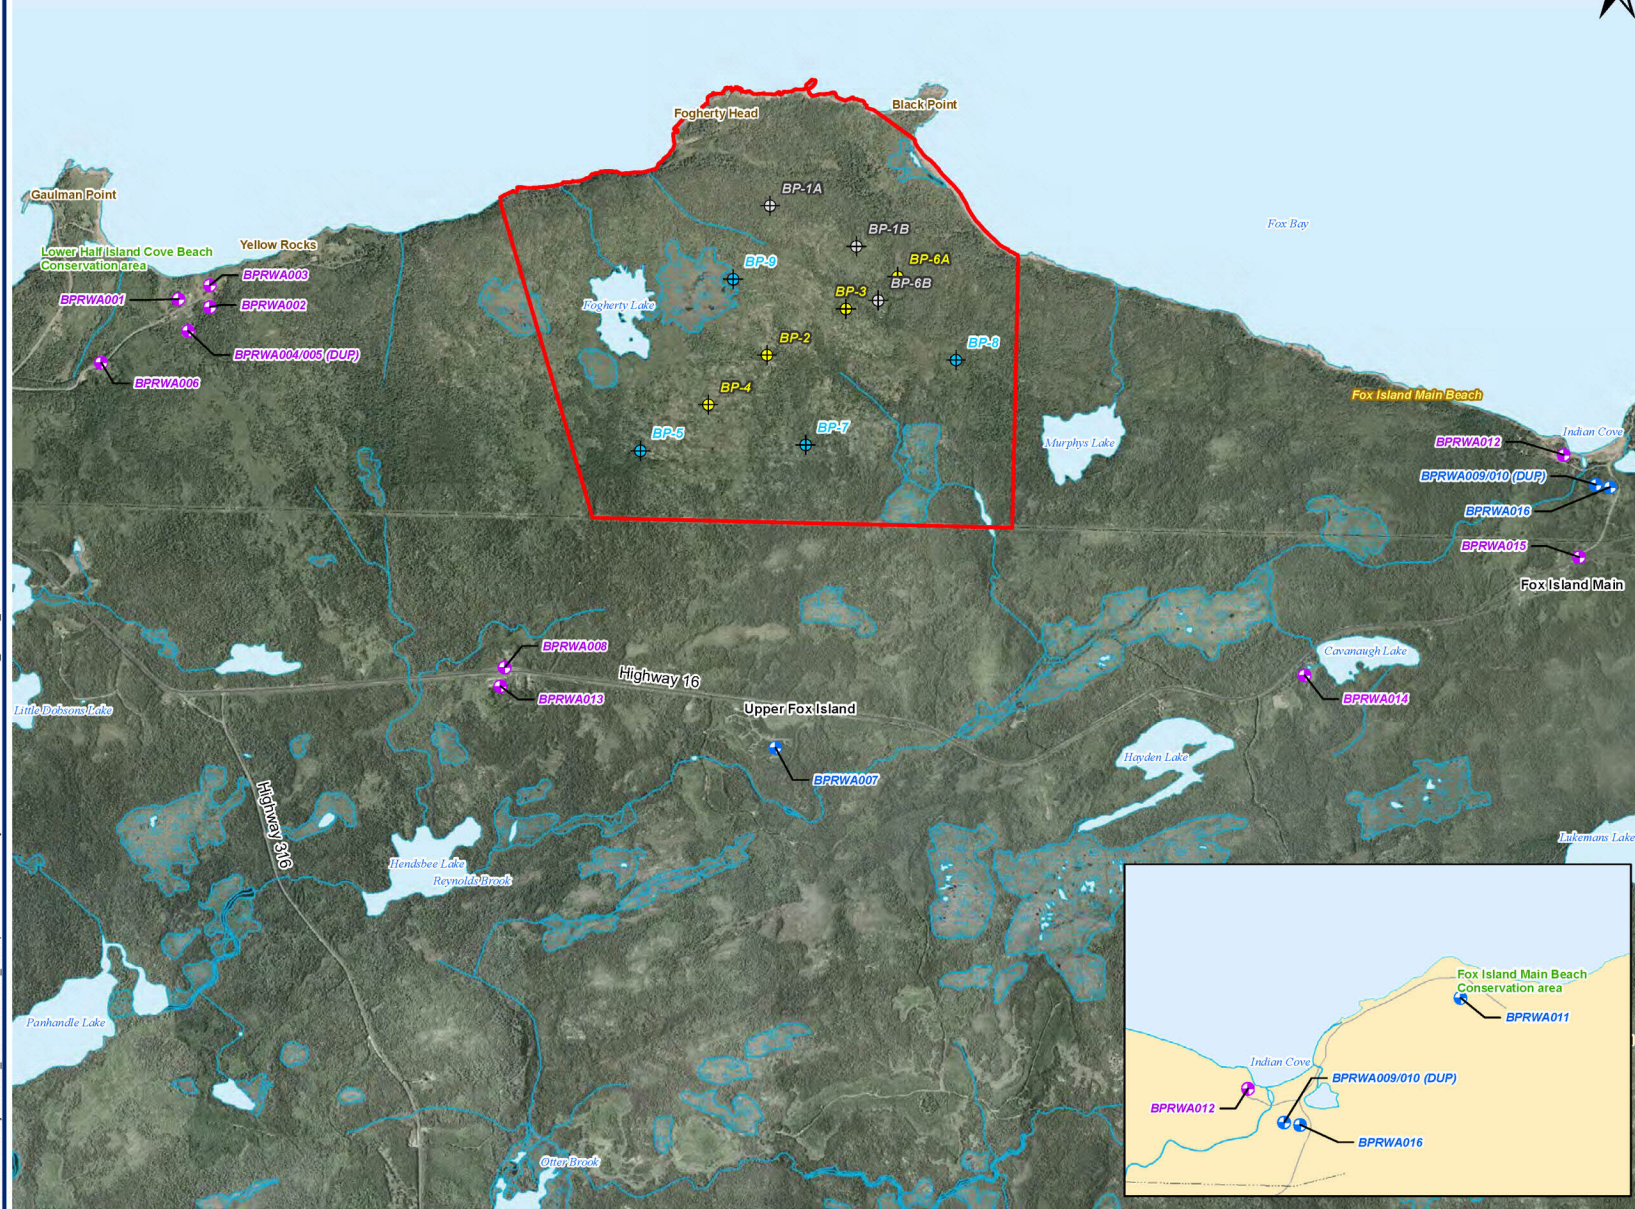
Figure 1 Residential Wells

Figure 1 identifies the locations of the residential wells and **Table 1** summarizes the information collected from the questionnaires.

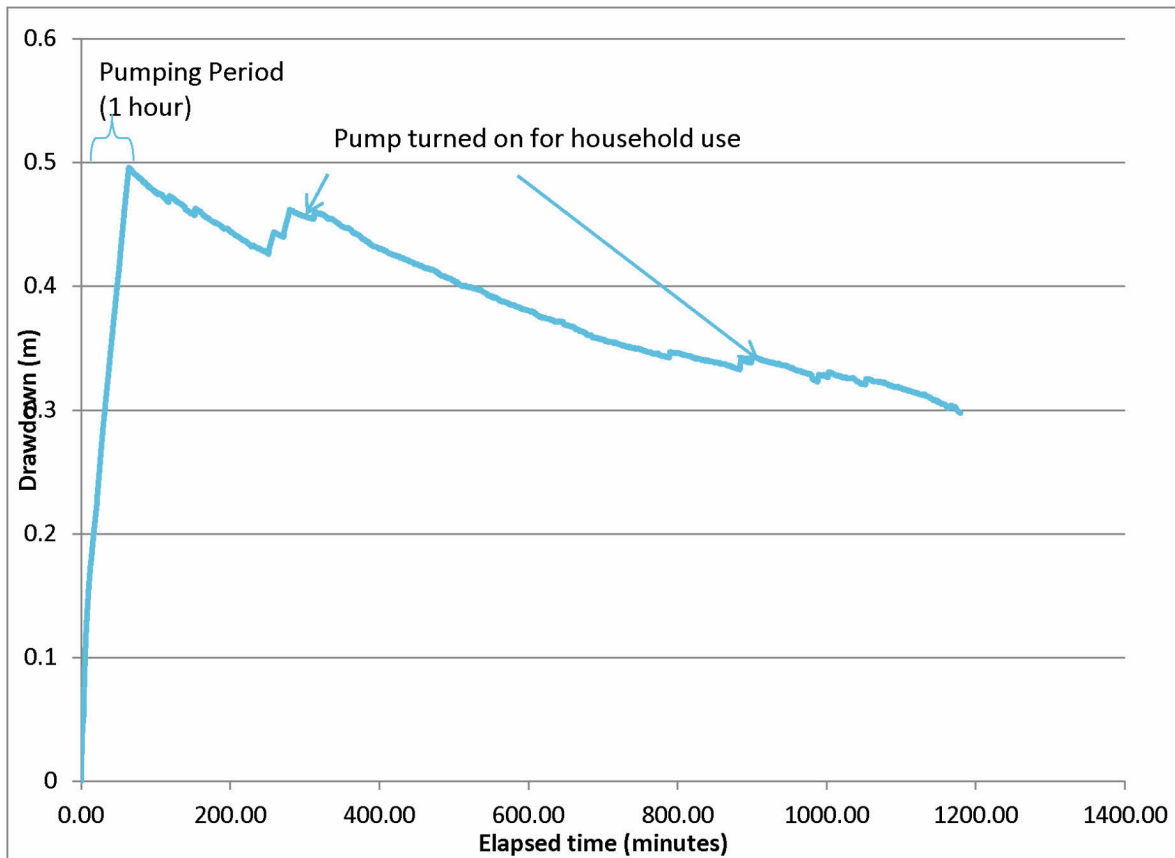
Figure 3: BPRWA001 Yield Test Observations

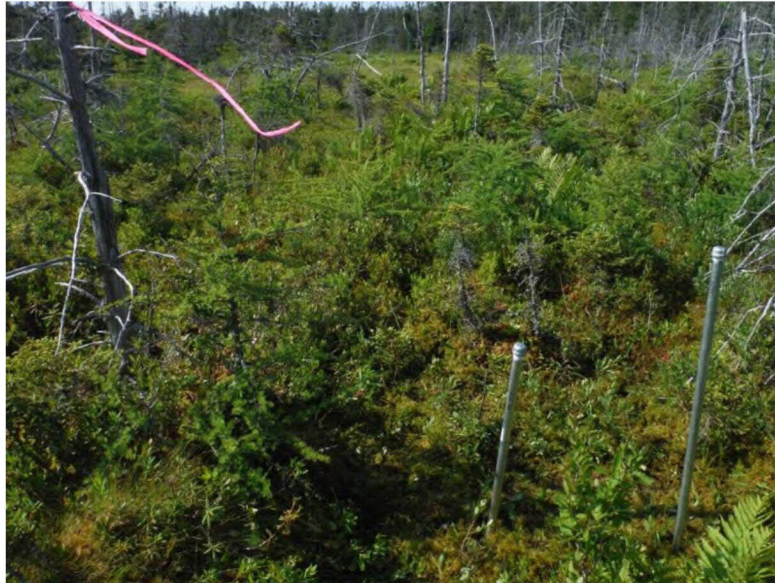
Photo 1: MP4

MP4 is located in a small wetland area in the eastern portion of the property. Topography indicates the wetland drains to Murphys Lake. The wetland was wetter than those hosting the MPs installed near Fogherty Lake. Outcrops of bedrock are visible within 50.0 m of MP4. Bedrock was encountered at a depth of ~ 3 m.

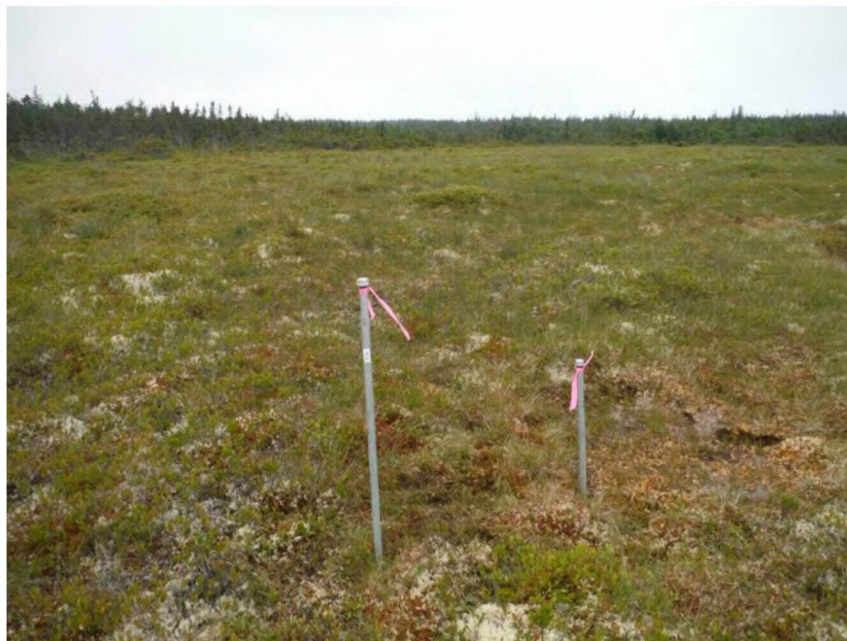
Photo 2: MP5

MP5 is located in a large wetland area at the southern end of the property. The wetland feeds a stream discharging to the south (BPSTR012 stream monitoring location). Thick sphagnum moss and peat is found to a depth >1.5 m. Bedrock depth is variable from 1.5 m to 3.5 m.

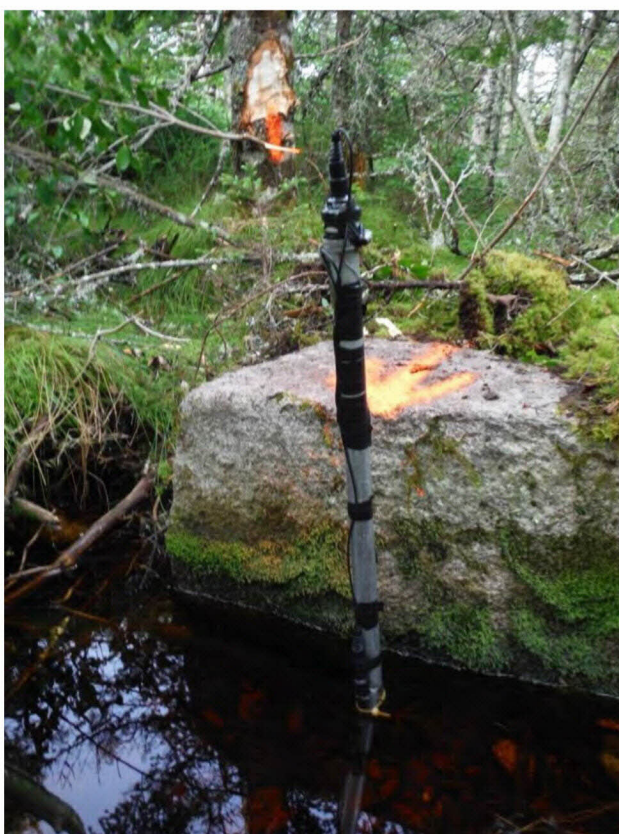
MP6 is a single 1 inch piezometer installed in the stream discharging from Fogherty Lake. The stream bed has sand, gravel, cobbles and boulders. Piezometer refusal was common at a depth of 0.5 m. Stream flow measurement, surface water sampling and field parameters measurements were completed at MP6. The piezometer is instrumented with a data logger.

Photo 3: MP6 with Data Logger

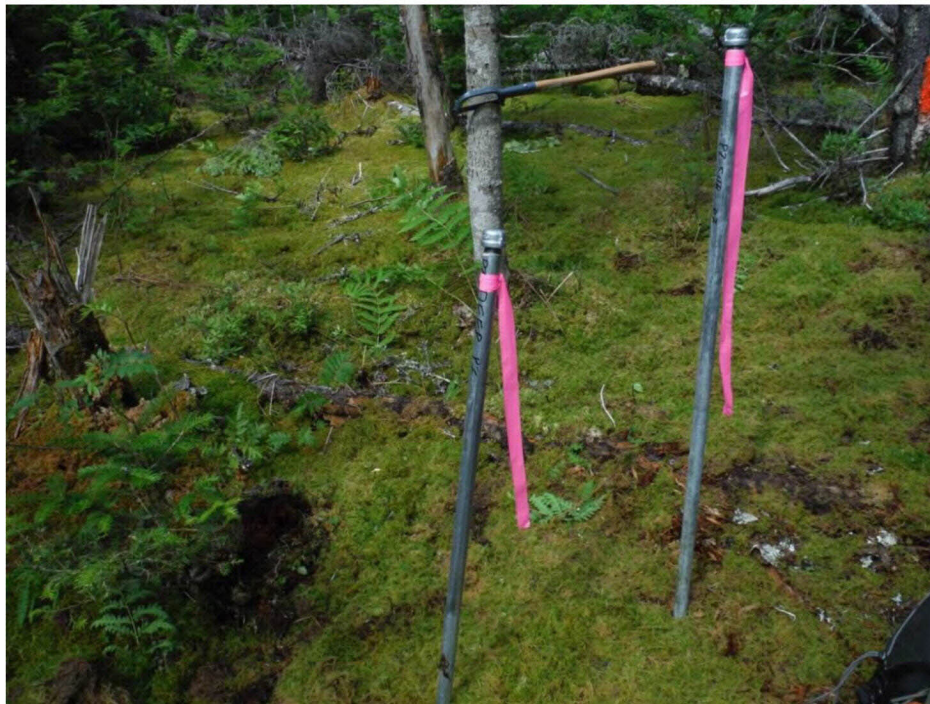
Photo 4: MP7

MP7 is located in a northwest trending lineament with ~ 10 m of relief, which is 5 to 10 m wide. No water was running at the location and there is no indication of a stream bed. A nested set of MPs were installed. Moss is found to a depth of 0.5 m, followed by sediment/till. Bedrock/piezometer refusal was not encountered, but piezometer insertion was increasingly difficult past the first pipe length.

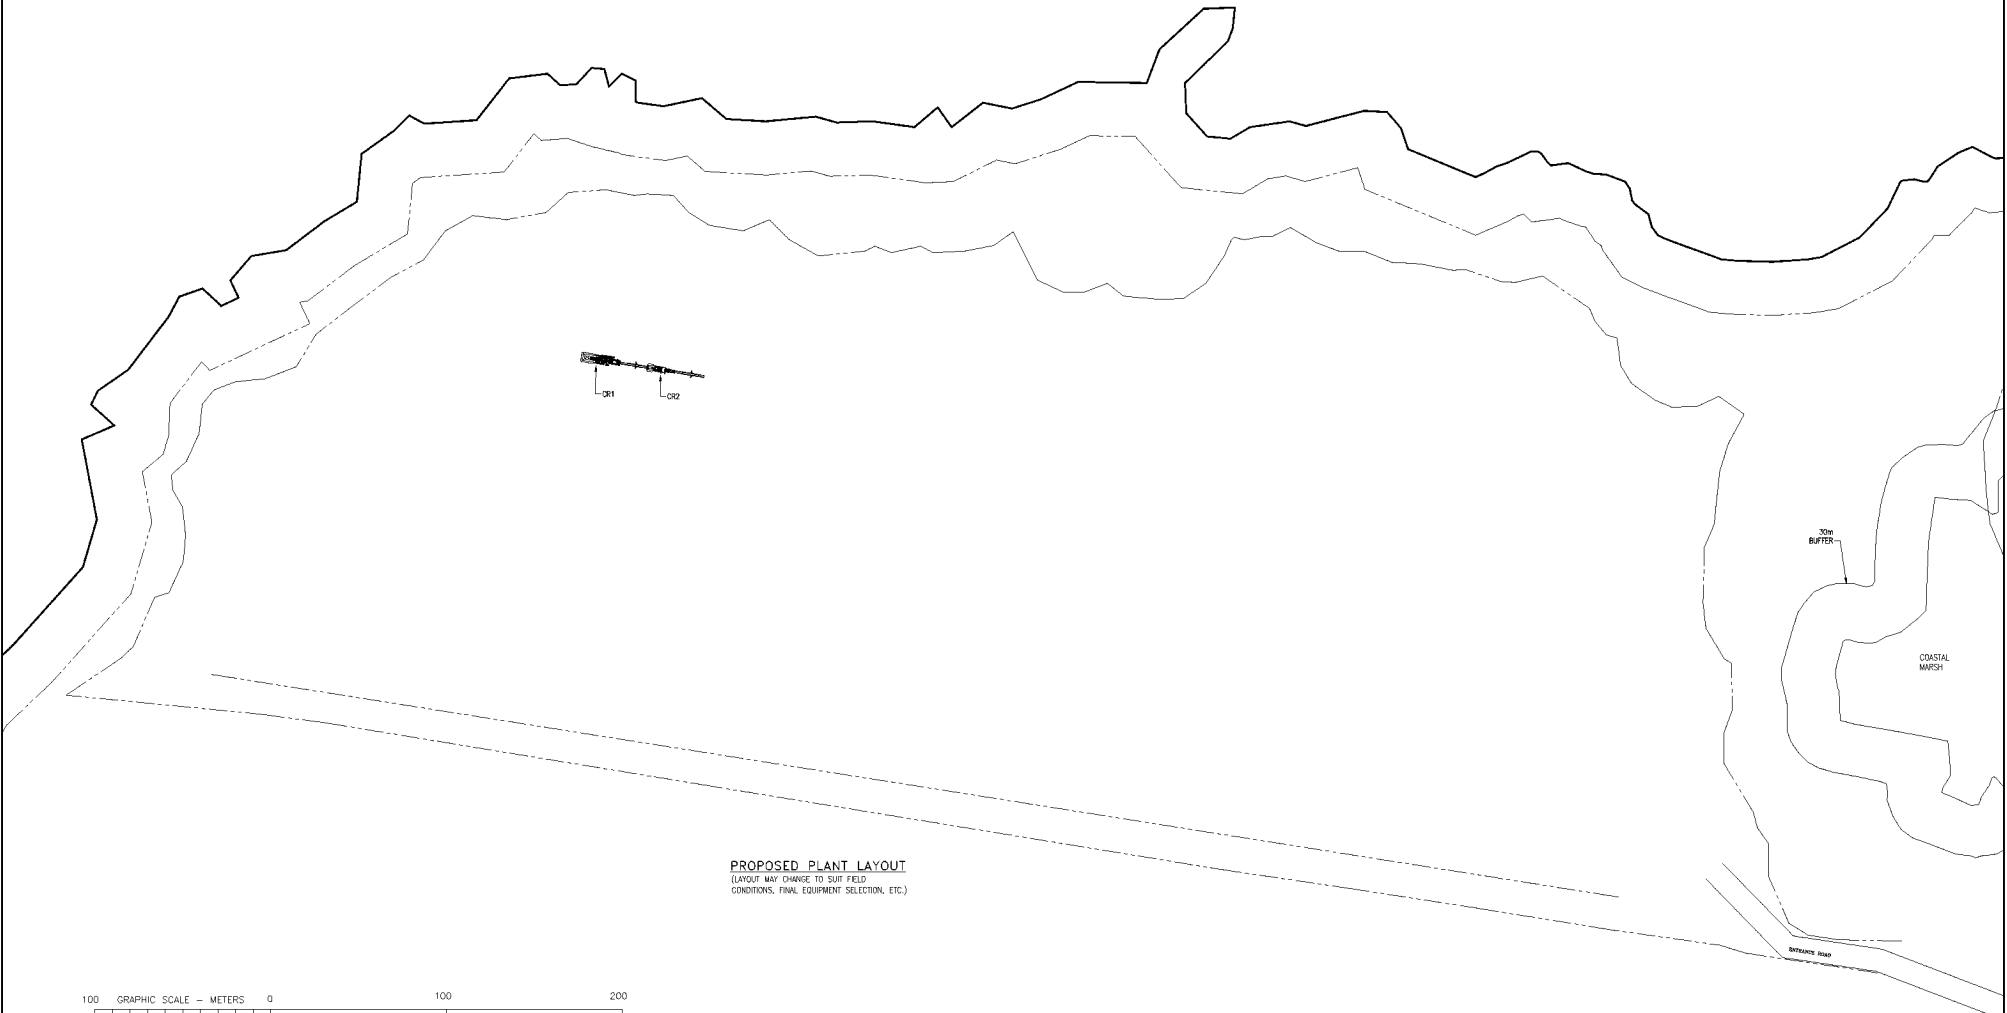
D		C		B		A		-		DATE		REVISION		BY		TOLERANCES—UNLESS NOTED FRACTIONAL: 1/16" DECIMAL: 0.001" ANGLE: 0.1°				PLANT LAYOUT		NOVA SCOTIA		BLACK POINT	
																				PHASE #1		8/15/14		100-PLT-0001

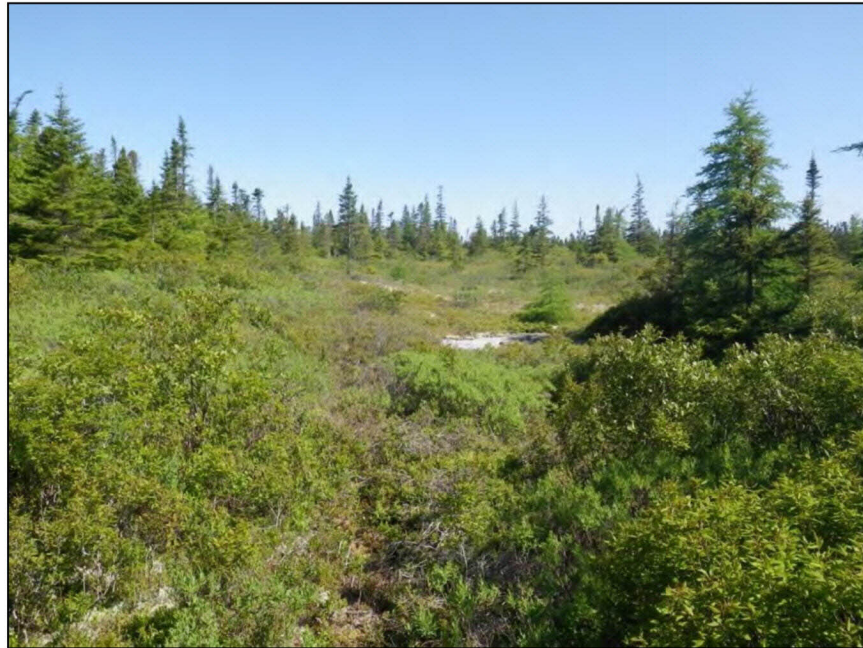
Much of the Project Site is dominated by low barren vegetation. This habitat type can either be dominated by shrub species such as huckleberry (*Gaylussacia baccata*), late low blueberry and common juniper (*Juniperus communis*) growing to heights of less than one metre. Other forms of this habitat type are dominated by black crowberry mats growing over rocks. This type of barren is typically located closer to the coast (on headlands), but can occur inland over bedrock outcrops.

Wetland Hydrology Indicators:
