Black Point Quarry Project
Municipality of the District of Guysborough, NS

Environmental Impact Statement

Vulcan Materials Company

February 2015

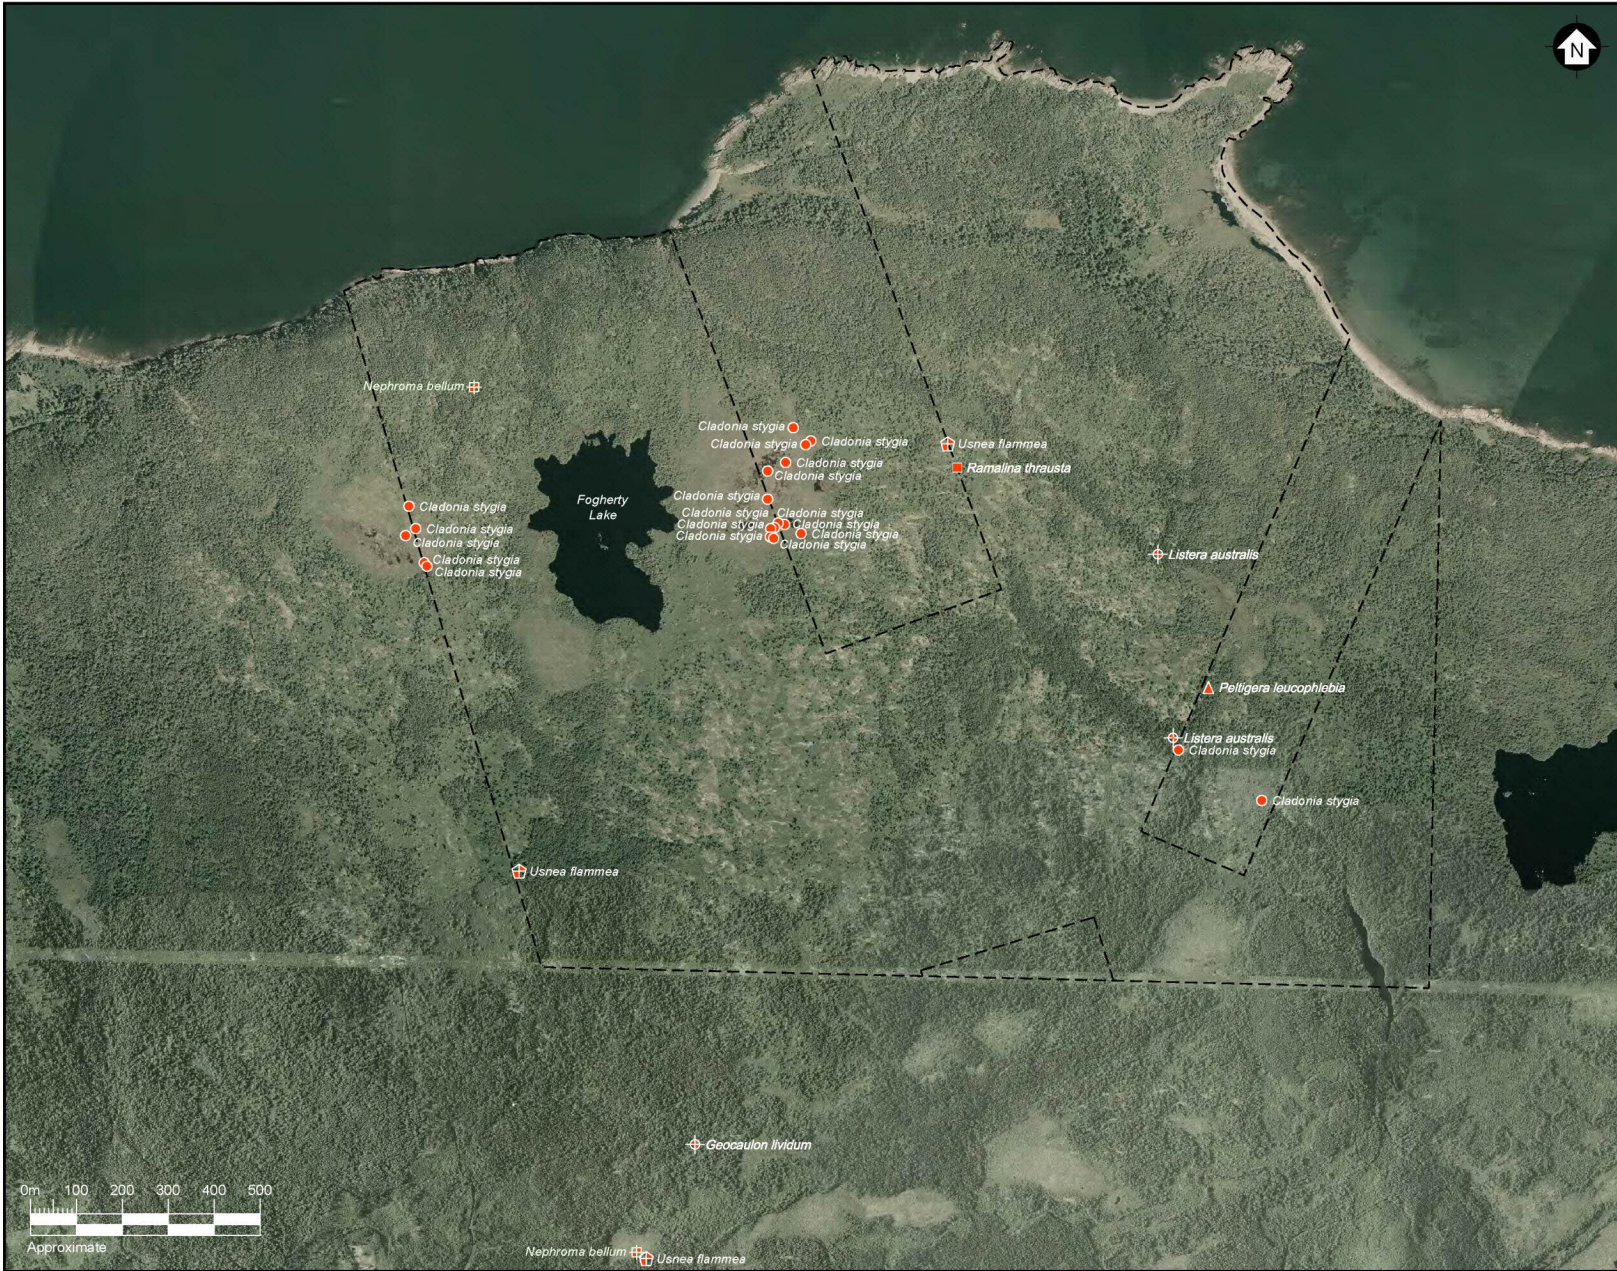
DWN BY:	DS	PROJECTION:	UTM Zone 20	DATE:	September 2014
CHKD BY:	SB	DATUM:	NAD83	PROJECT NO.:	TV144003
REV. NO.:	N/A	SCALE:	N.T.S.	FIGURE No.	2-1

One vascular plant species of conservation concern was detected on the Project Site during the June 2010 surveys. Southern twayblade (*Listera australis*) has an ACCDC rarity rank of S2. This species was encountered along two streams located within the Project Area. Figure 2-1 illustrates the locations where this species was encountered. One location contained over 40 individuals within a relatively small area whereas only one individual was found at the second location. This species is shown in Photo 2-9, while its habitat is depicted in Photo 2-10.

An additional plant species of conservation concern, Northern Comandra (*Geocaulon lividum* – ACCDC rank S3) was detected during the August 2014 field survey. This species was noted in Wetland 18 (WL18) in the open bog portion of this wetland. Numerous individuals were reported throughout this wetland. Figure 2-1 illustrates the locations where this species was encountered. This species is shown in 11, while its habitat is depicted in Photo 2-101.

Rare Vascular Plants and Lichens

A single cyanolichen species of concern was detected on the Site during the surveys in 2010. A specimen of *Peltigera leucophlebia* was detected at the location depicted on Figure 2-1. This

A second uncommon lichen (though not a cyanolichen), *Ramalina thrausta*, was found on the Site. The approximate location is depicted on Figure 2-1. ACCDC ranks this species as S2S3.

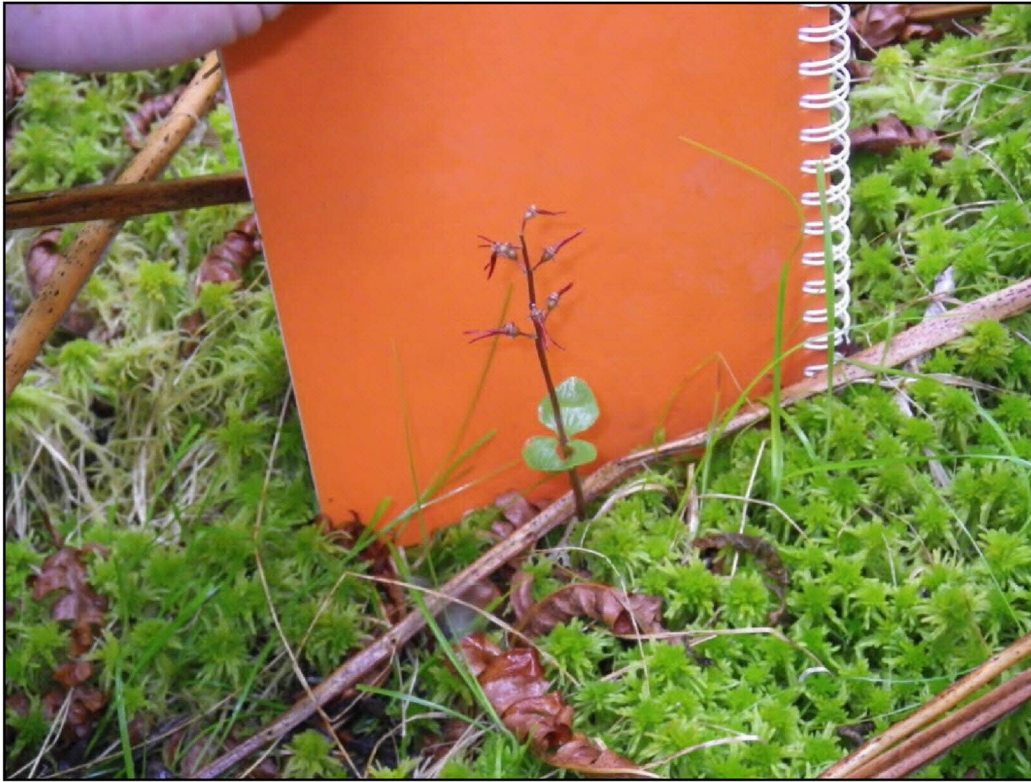
Photo 2-9. *Listera australis* in *Sphagnum* moss along stream

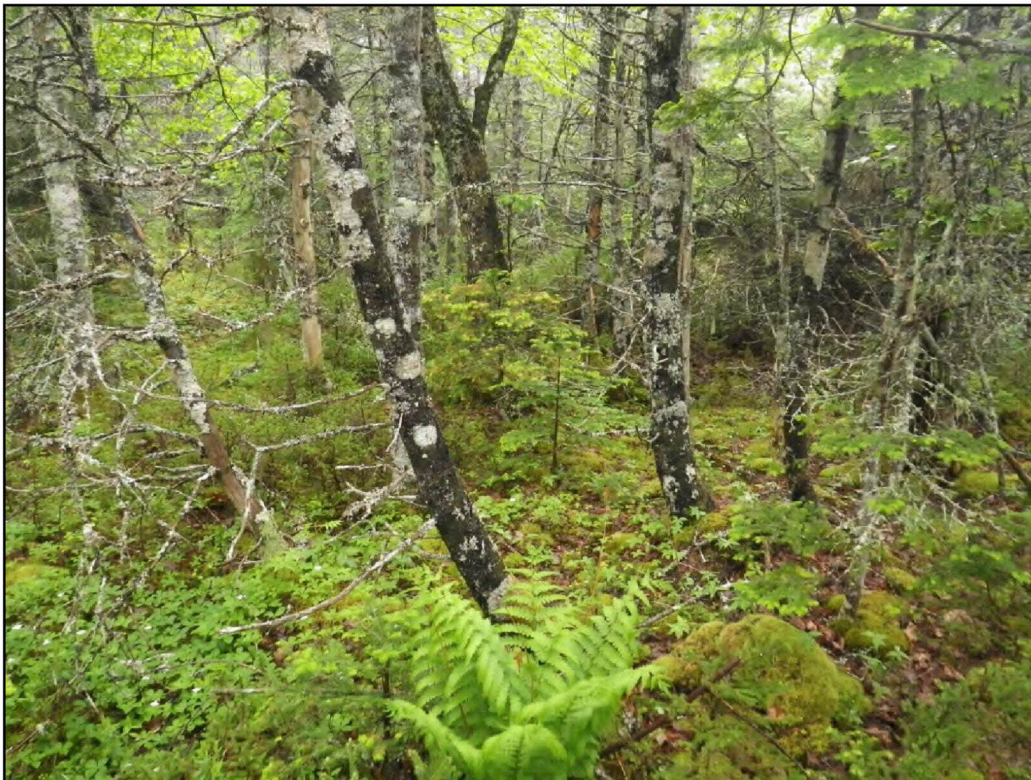
Photo 2-10. *Listera australis* habitat

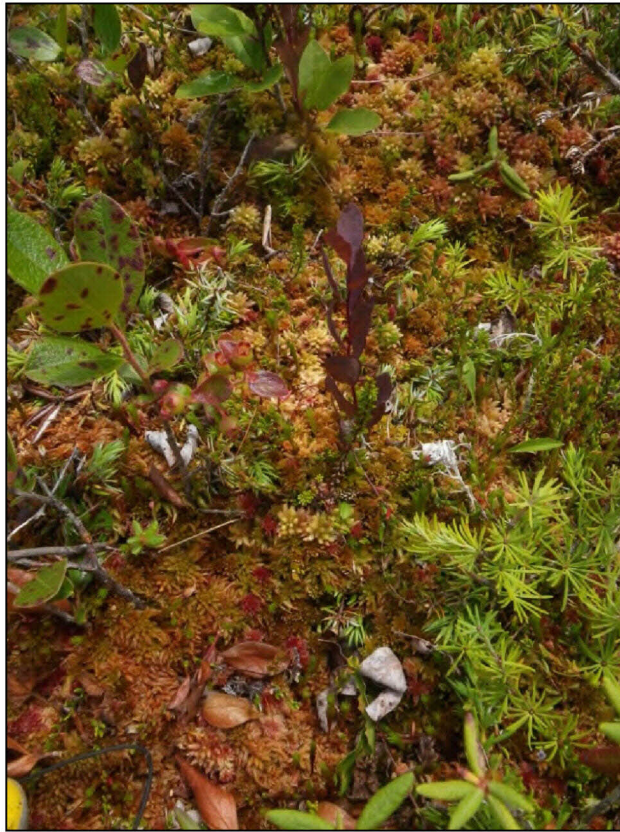
Photo 2-11. *Geocaulon lividum* in open bog

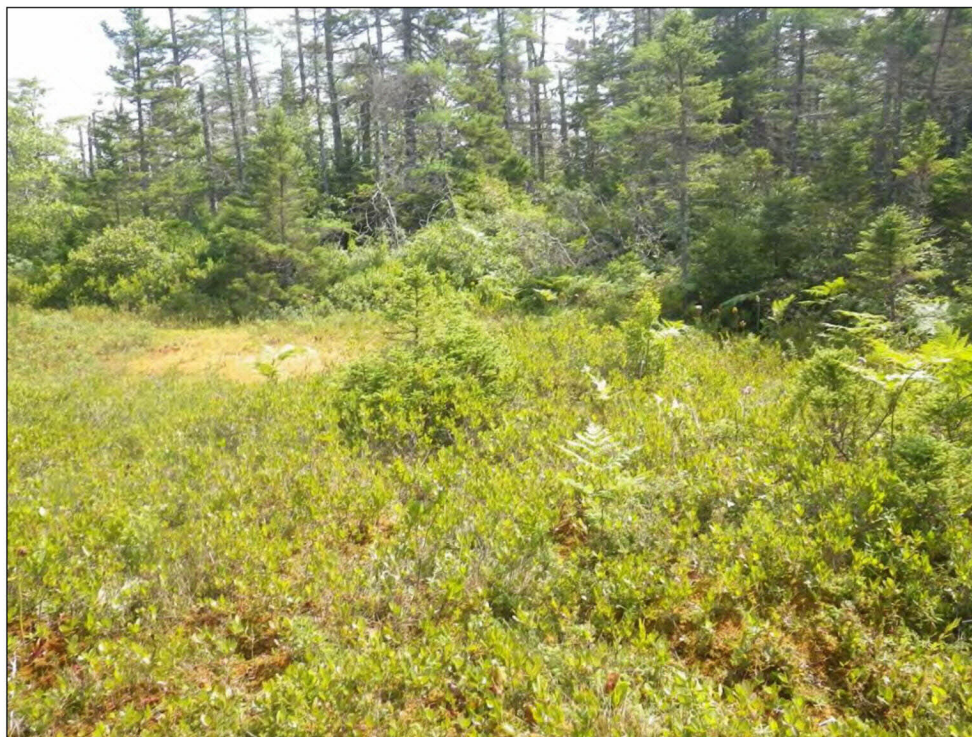
Photo 2-12. *Geocaulon lividum* habitat

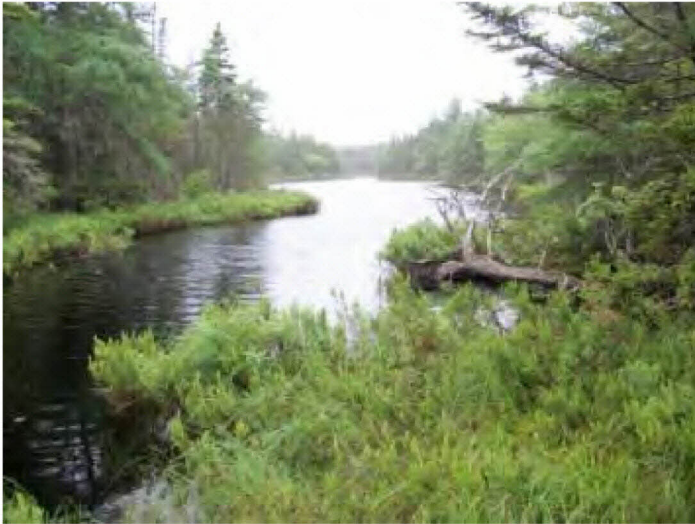
Two streams feed into this large beaver pond from the north. The wetland surrounding the pond is narrow and in some cases non-existent due to steep rock outcrops at the edge of the water. The beaver dam is at the southern end of the open water. Forested wetland is present at the bottom of a steep slope in the southern quadrant near the power line and riparian shrub wetland is associated with both streams.

Open water seen from the south with some riparian Shrub Wetland

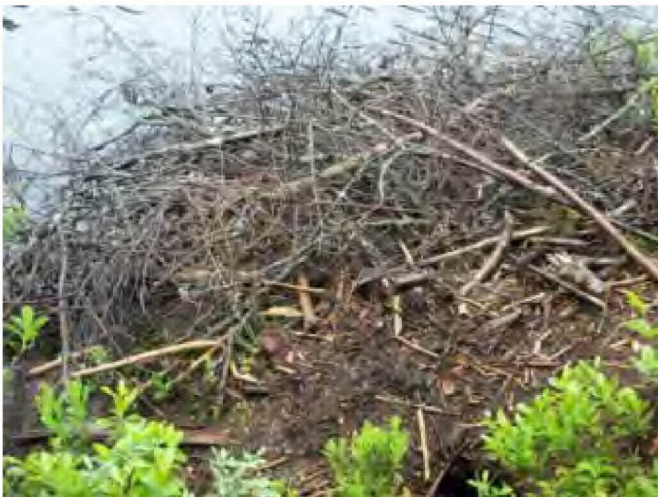
Beaver lodge

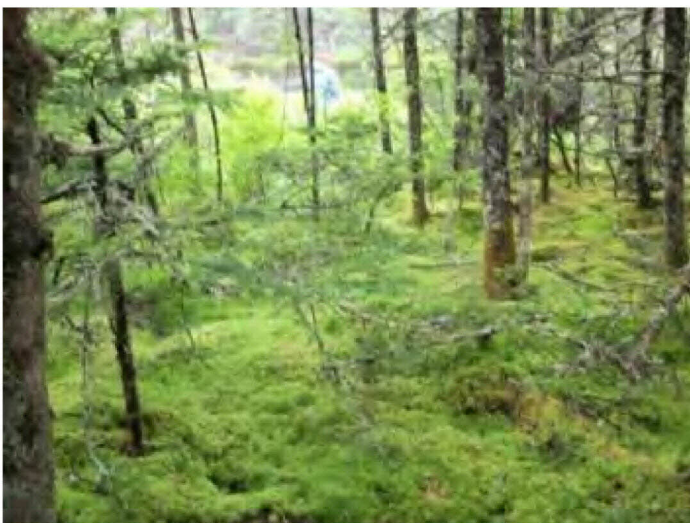
Forested Wetland at Wetland 1

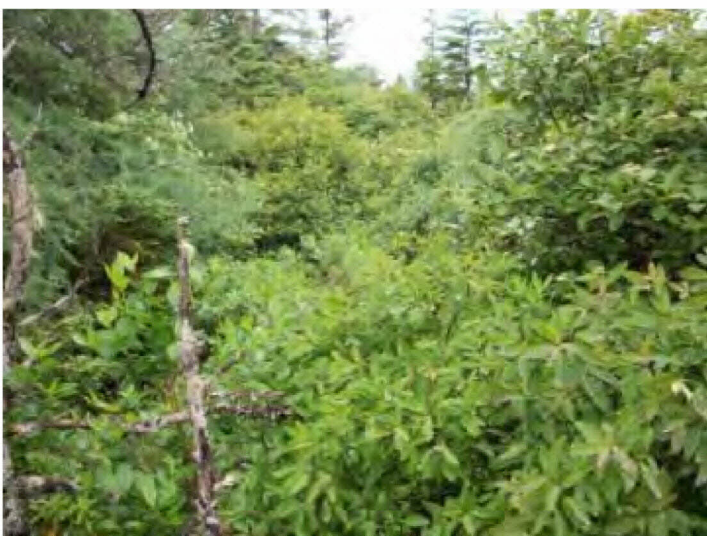
Shrub Riparian Wetland where Wetland 1 joins Wetland 17

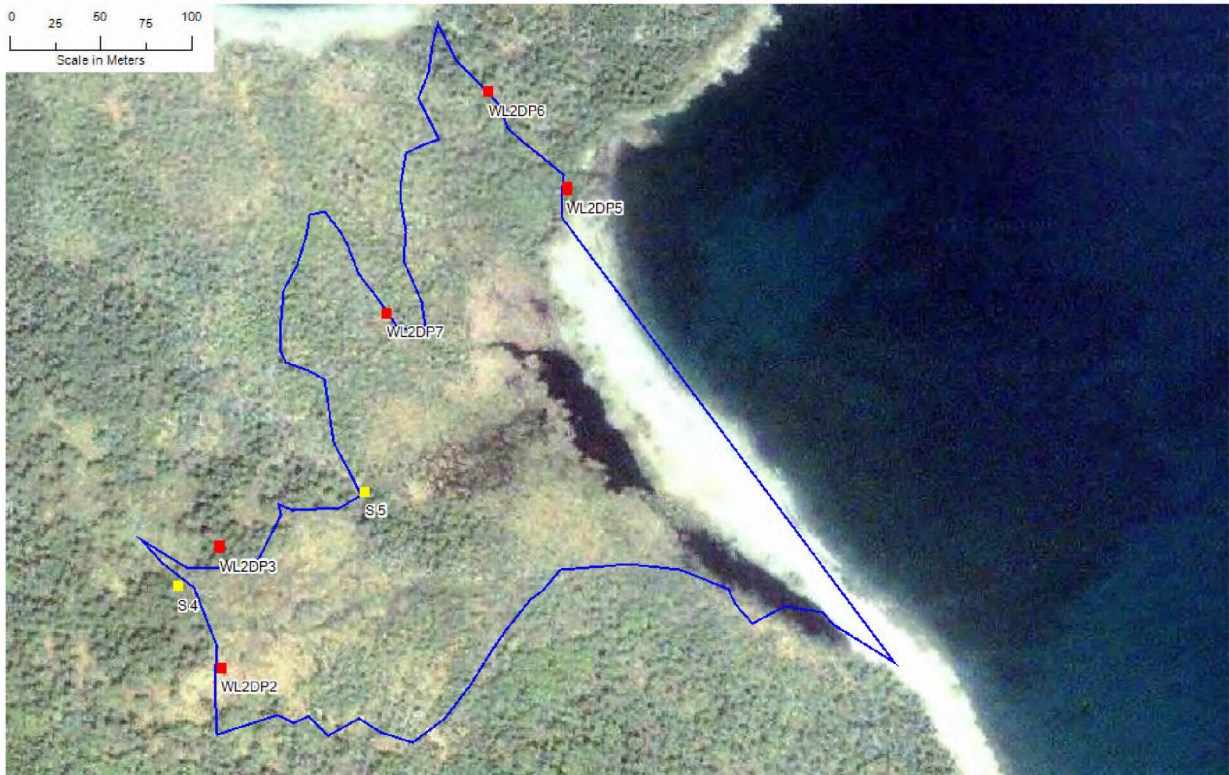
Wetland 2 is a complex of habitat types including marsh, swamp, forested wetland and riparian wetland. This delineation was problematic because of transitional habitat which stretched between the two coastlines behind the headland. Historic habitation was also present but had little effect on wetland habitat although some fern-dominated wet meadow habitat was identified in isolated areas. Some microtopographical relief was present along the western and southern edges of the complex. Open water was found not to be brackish.

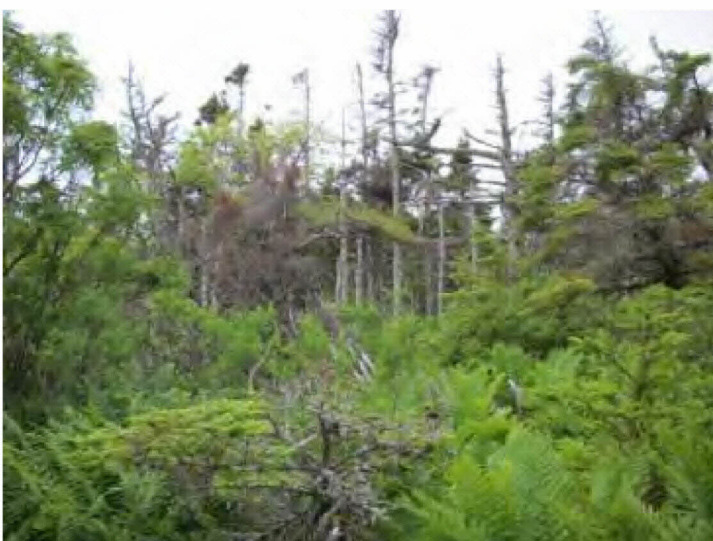
Transitional wetland habitat dominated by shrubs and blown down conifers behind the headland west of the main estuary

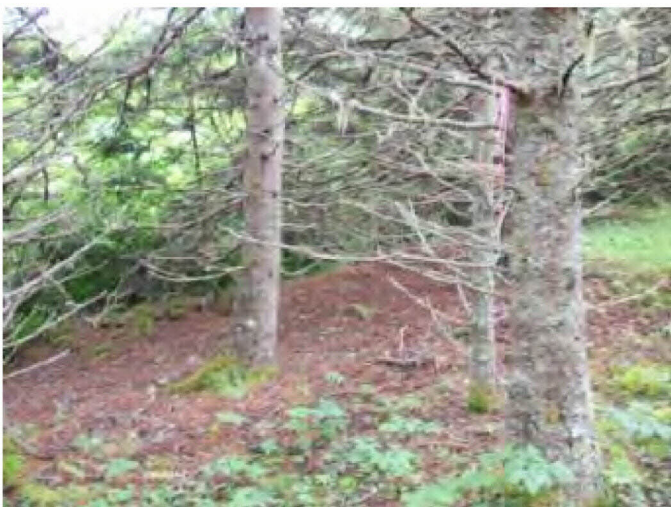
Upland near Wetland 2

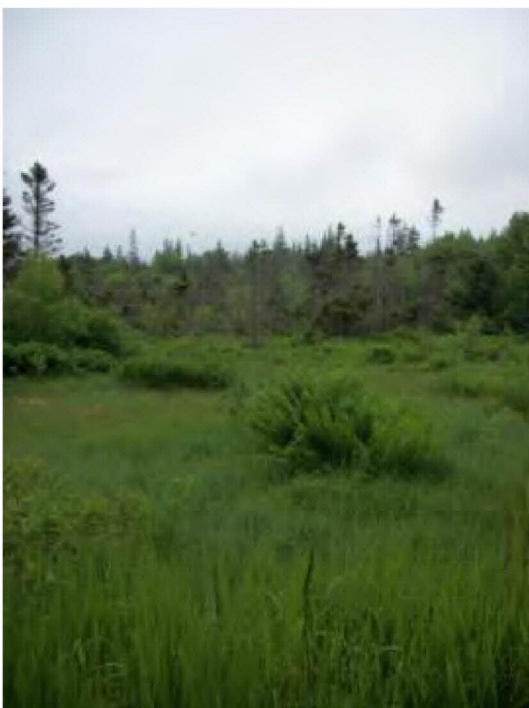
Marshy fen portion of the Wetland 2 complex

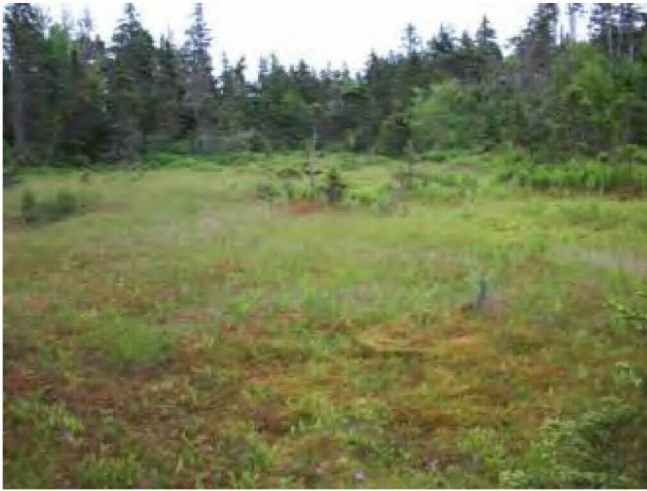
Wetland 3 is a fen dominated by typical bog/fen species of wetland plants and surrounded by steep rock outcroppings covered with a thin layer of organic soil. A small stream runs along the side of the wetland at the base of one of these steep banks and some transitional shrub wetland occupies the edge of the clearing.

Open Fen at Wetland 3

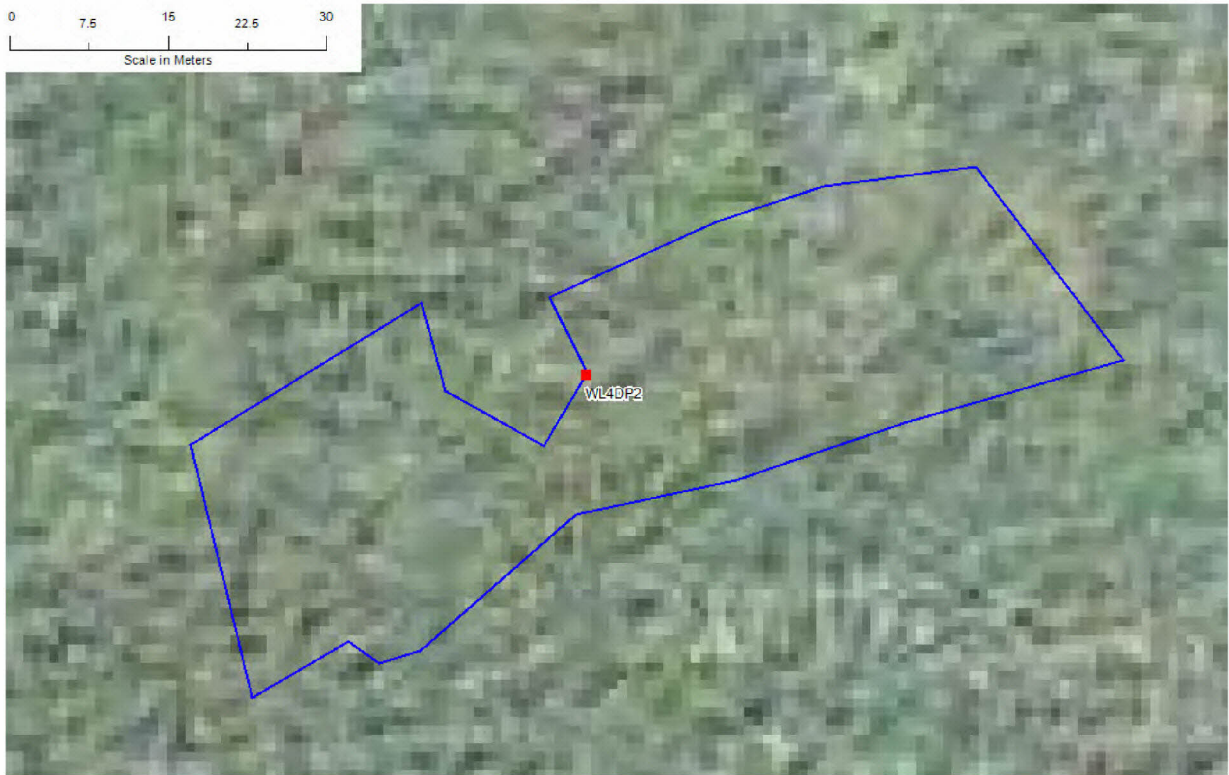
Wetland 4 is a Forested Wetland dominated by Red Spruce (*Picea rubens*) and with an open understory dominated mostly by Sphagnum and by only a few species of herbs and shrubs. This is a relatively small wetland which has formed amongst the variable contours of bedrock and can be distinguished by the surrounding forest largely by the presence of Sphagnum and organic soils.

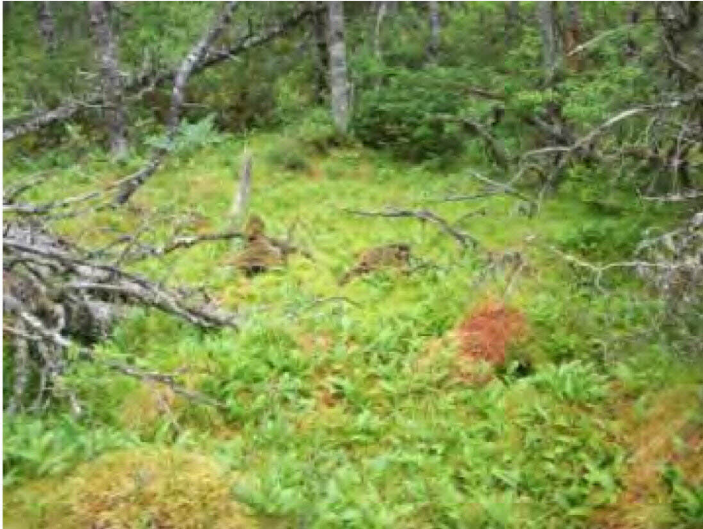
Forested Wetland with open understory dominated by few herbaceous plant species and abundant mosses

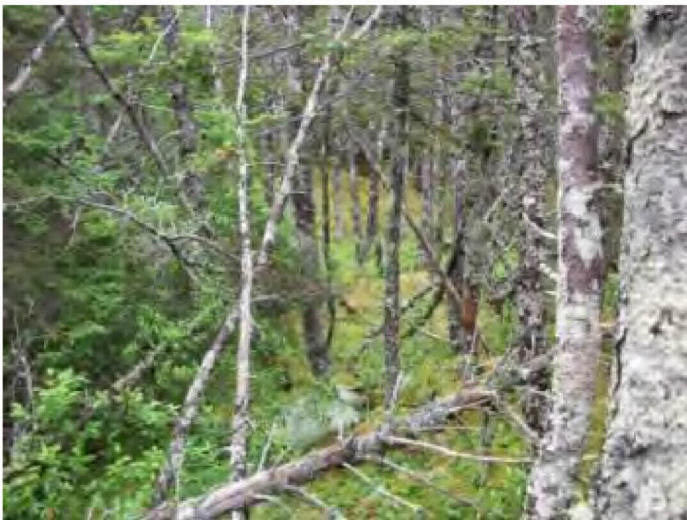
Forested Wetland and adjacent upland differ in hydrology, soil profile and bryophyte flora

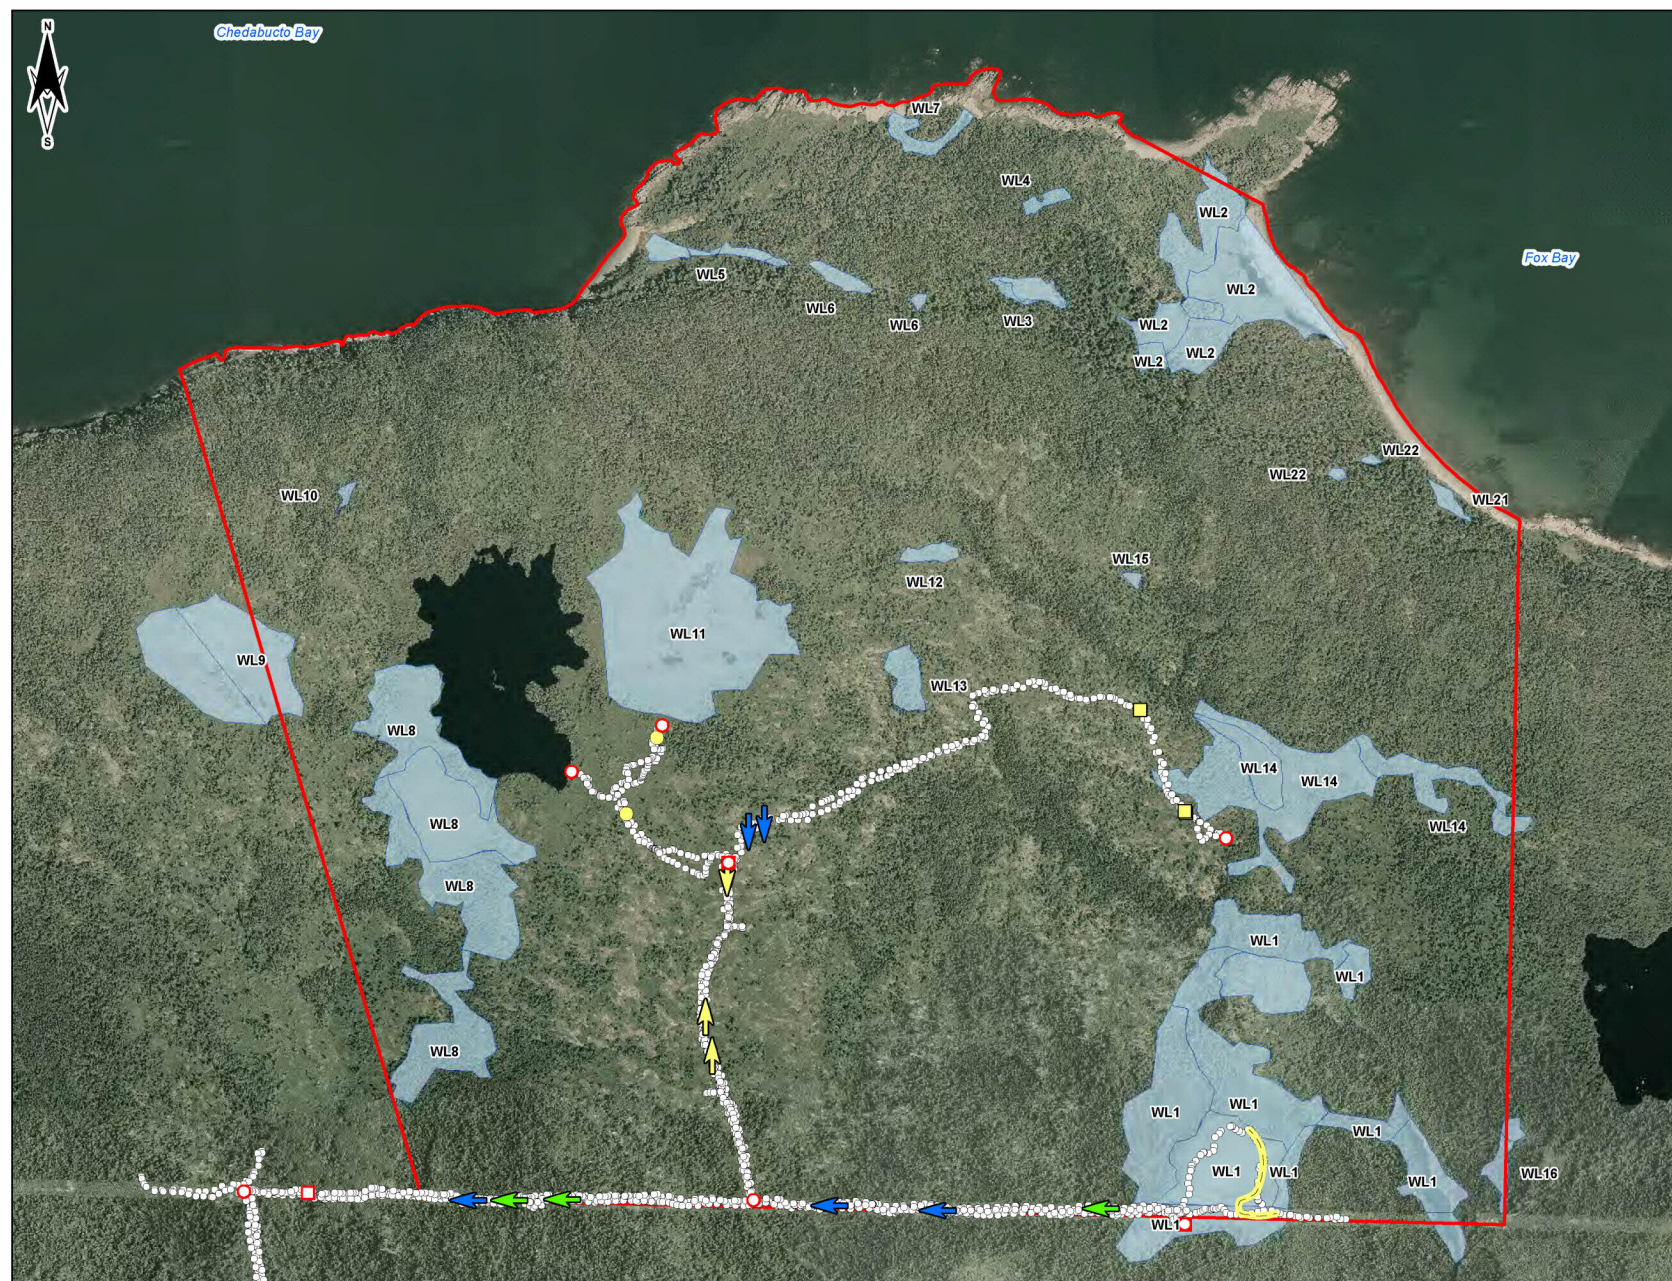
A total of seven calling stations were established and three scent markers were deployed on the Project site (Figure 3.1); however, no moose were observed during the surveys, and no recent evidence of moose was noted when surveyors returned to the calling stations and scent markers. Evidence of past moose presence was noted in the Project site; tracks were observed at several locations, and there was some moose scat and possible scrapes (Figure 3.1). These observations are further discussed below.

Two areas identified as possible moose scrapes were noted in the area between Fogherty Lake and WL11 (Appendix A, Photo 1); however, Mr. Prosper noted that a tree with rubbed bark would typically be seen in close proximity to a moose scrape, and no such trees were found near either of these locations. These possible scrapes were not recent, and no additional sign was noted in the area. Moose tracks were observed by AMEC northwest of Fogherty Lake in August 2014 (Figure 2.1), indicating that moose occasionally use this part of the Project site.

Moose tracks were observed in a few locations in muddy parts of the trail that runs in a north-south direction through the barrens in the centre of the Project site. This open area of barrens could serve as a corridor for moose to move between the areas of potential habitat to the west (Fogherty Lake and associated wetlands) and east (WL1 and WL14) of the Project site. However, the tracks that were seen on the trail were all made by animals travelling along the trail, not across it in an east-west direction (Figure 3.1), suggesting that moose may not be using the barrens as a direct route between these two wetland areas. At least two distinct sets of tracks were observed, one made by an adult bull (Appendix A, Photo 4) and one by a 3 or 4 year old male, but none of the tracks appeared to be recent.

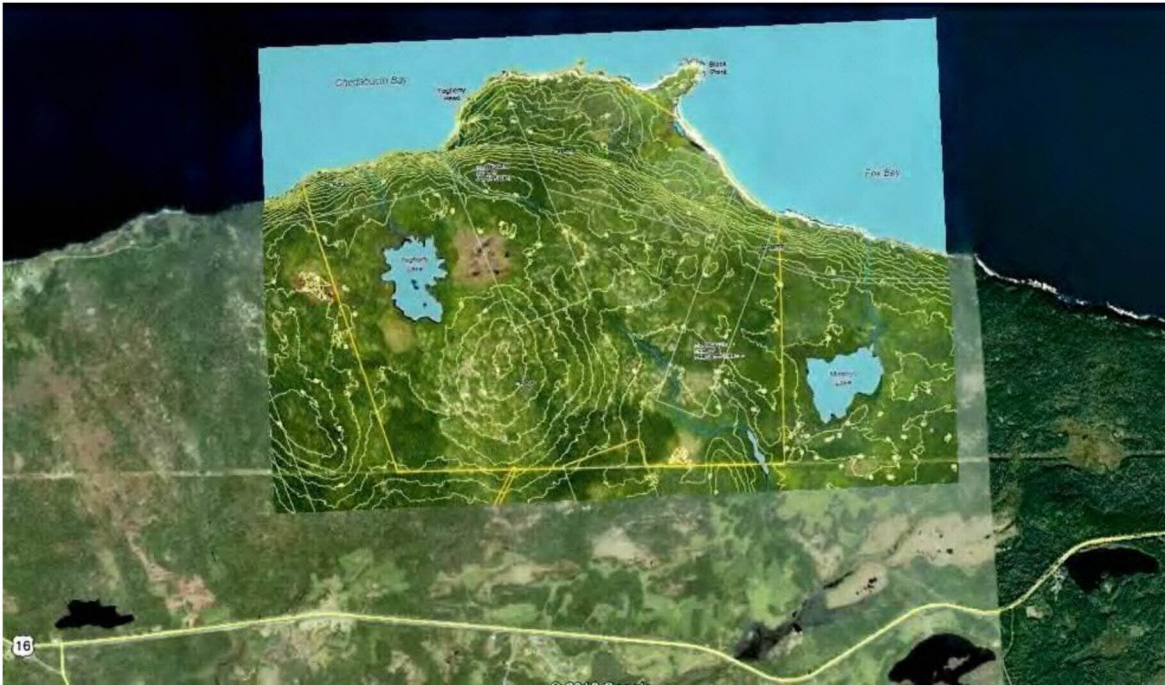
Fig 6: Project area with contour lines³

While Figure 5 offers a simulated view of the natural landscape based on satellite imagery, figures 6 and 7 illustrate the area's relief more clearly through contour lines and a LIDAR image modelling the surface structure underneath the vegetation cover. The hill featuring the resource to be quarried has an elevation of about 103 m above mean sea level².

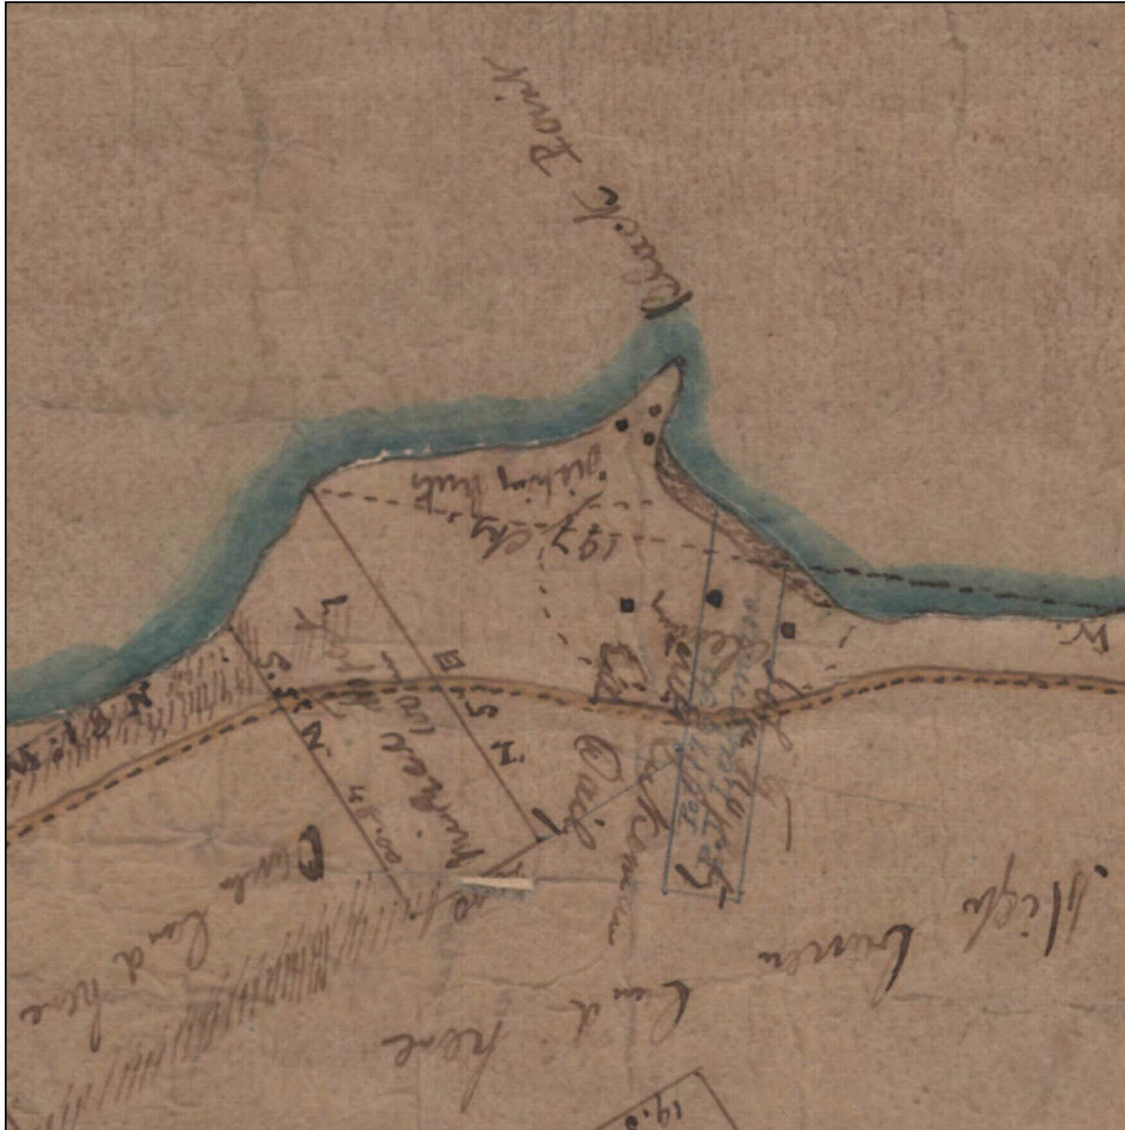
Figure 3.2-5: Detail of an 1883 map from the Crown Lands office shows the homes of Mrs. Lukeman and Ed. Daily (Edward Daly) within the study area, and John Fogarty just outside the study area to the east. Note the dotted line most likely indicating an agricultural area around the three houses. Three “fishing huts” are also shown on Black Point outside the study area, while the granite barrens to the south are marked as “High barren land here.”¹⁹

An 1883 map from the Crown Lands office shows the homes of Edward Daly and Mrs. Lukeman within the study area (Figure 3.2-5), while John Fogarty is shown, surprisingly, immediately east of the Lukeman grant and just outside the study area. Three "fishing huts" are also shown on Black Point itself, outside of the study area.

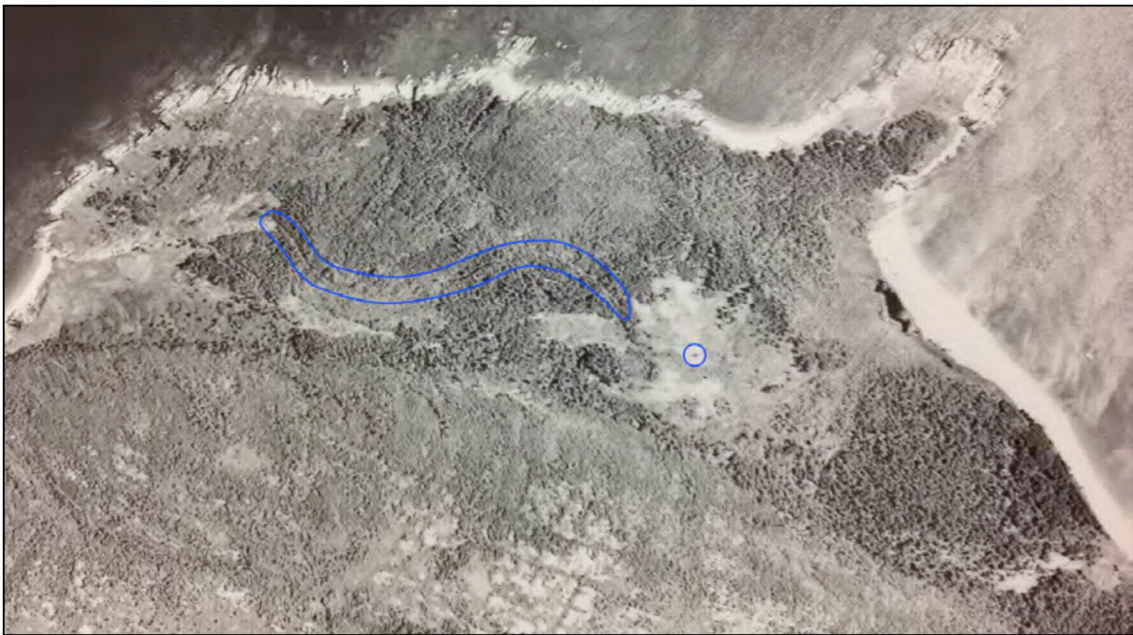
Figure 3.2-7: A 1954 aerial photo shows what appears to be a road on Fogherty Head as well as a possible house (blue).²⁶

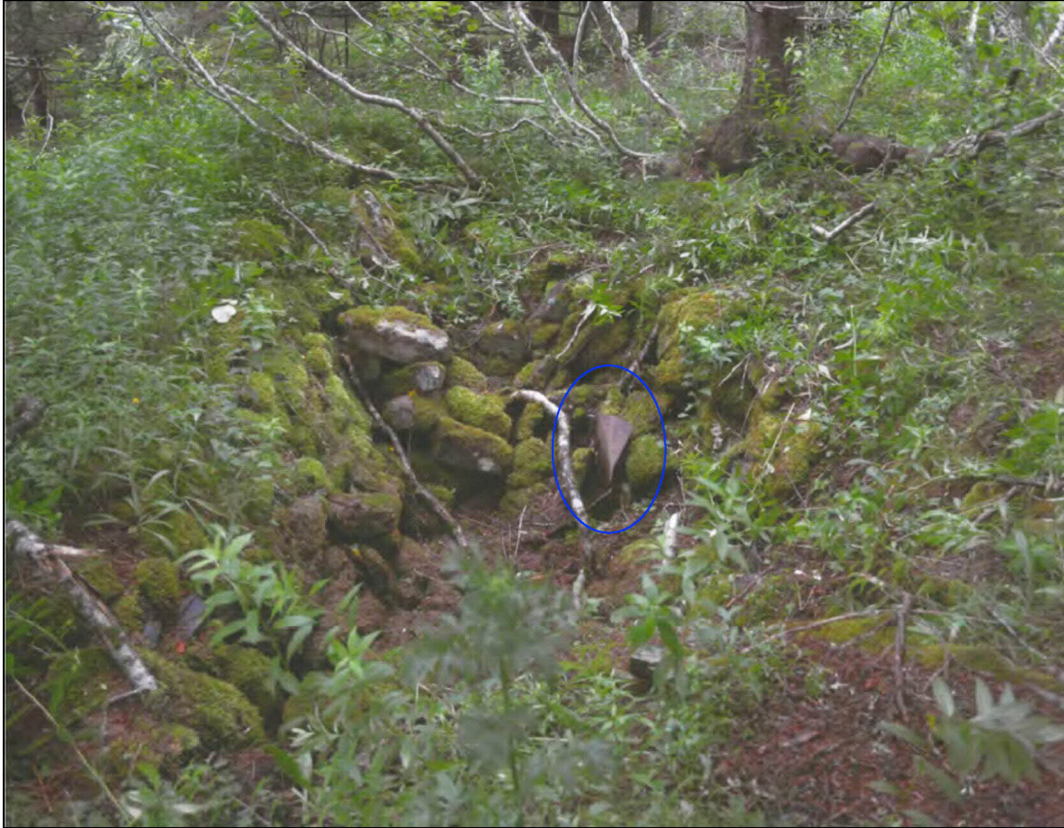
Figure 3.2-8: A photograph supplied by Frank Fogarty of one of the foundations at Fogherty Head. Note the distinct metal fragment inside the cellar (blue), which allowed the archaeological team to confirm that this cellar is one of those identified during the reconnaissance as belonging to the Daly family.

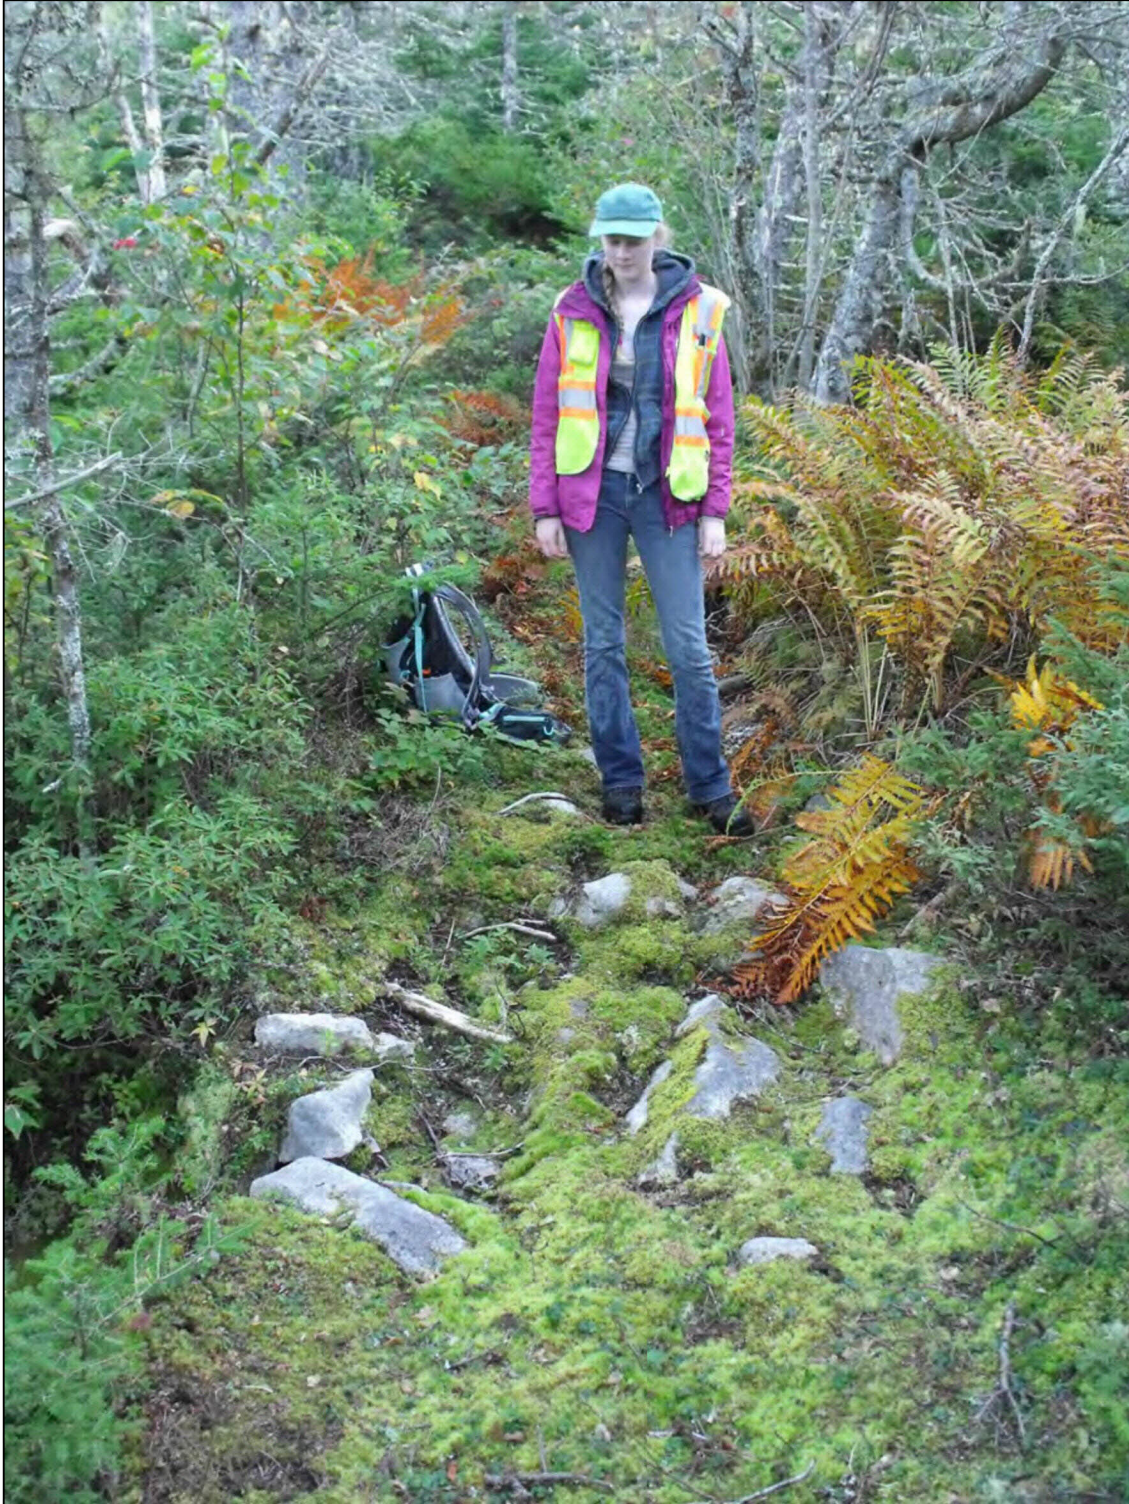
Plate 3: Loose stone piled across a small gap in the bedrock where a tiny stream flows down from the barrens. Looking east.

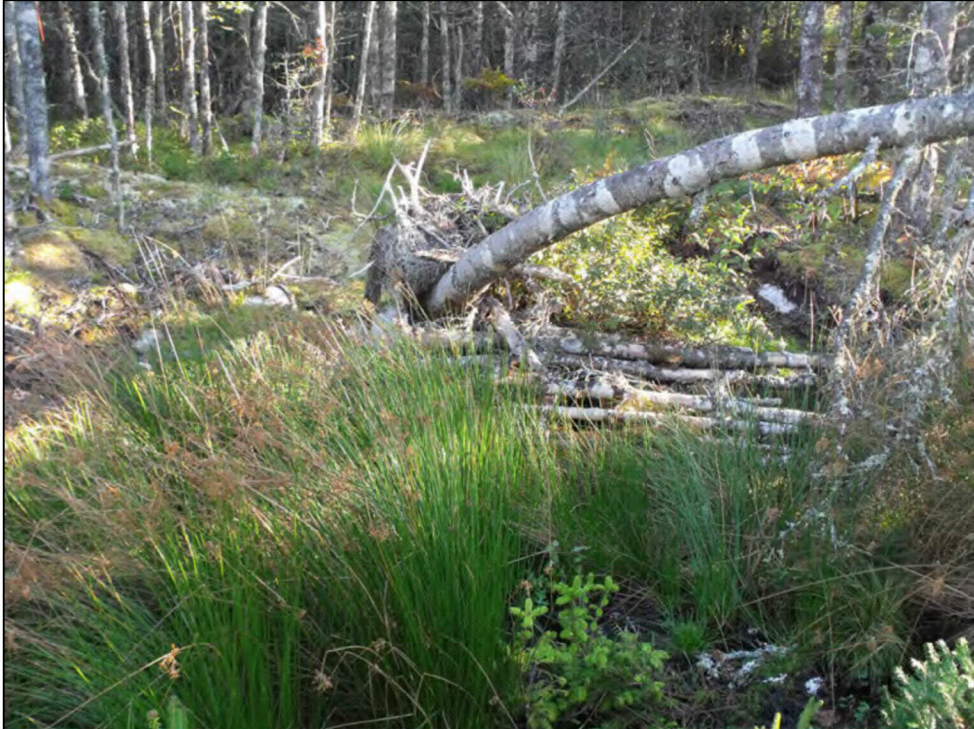
Plate 4: A rough spruce rail ATV bridge survives under a partially fallen spruce tree. Looking east.

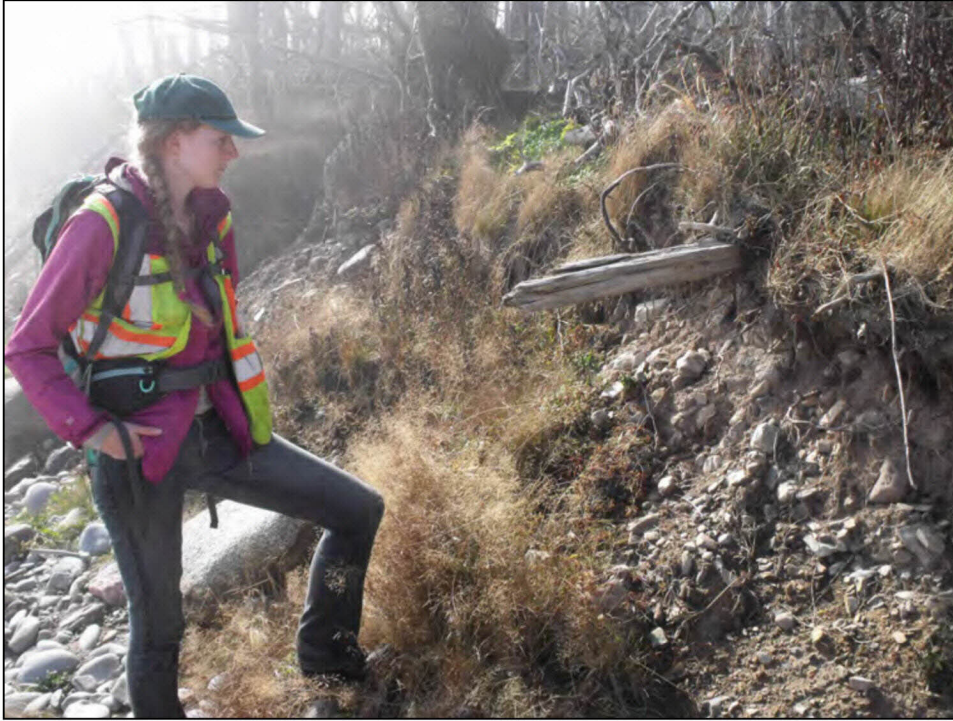
Plate 20: A weathered square timber protrudes from the erosional face along the eastern cove, looking south.

Beyond the barachois as the team continued south along the shore, the land above the beach rises dramatically to produce a sloped erosional face of soil rather than bedrock (Plate 19). All exposed soils were examined, but beyond modern beach debris the only cultural material observed against or in the erosional face was a square-cut timber approximately 4"x4" protruding from the bank (20 T 645671 5023912) (Plate 20). The timber may represent the remnants of a small wharf, but in the absence of any other timber nearby or any signs of cultural activity on the shore above the timber, it appears more likely that it is an isolated fragment, perhaps related to signage or a hunting blind.

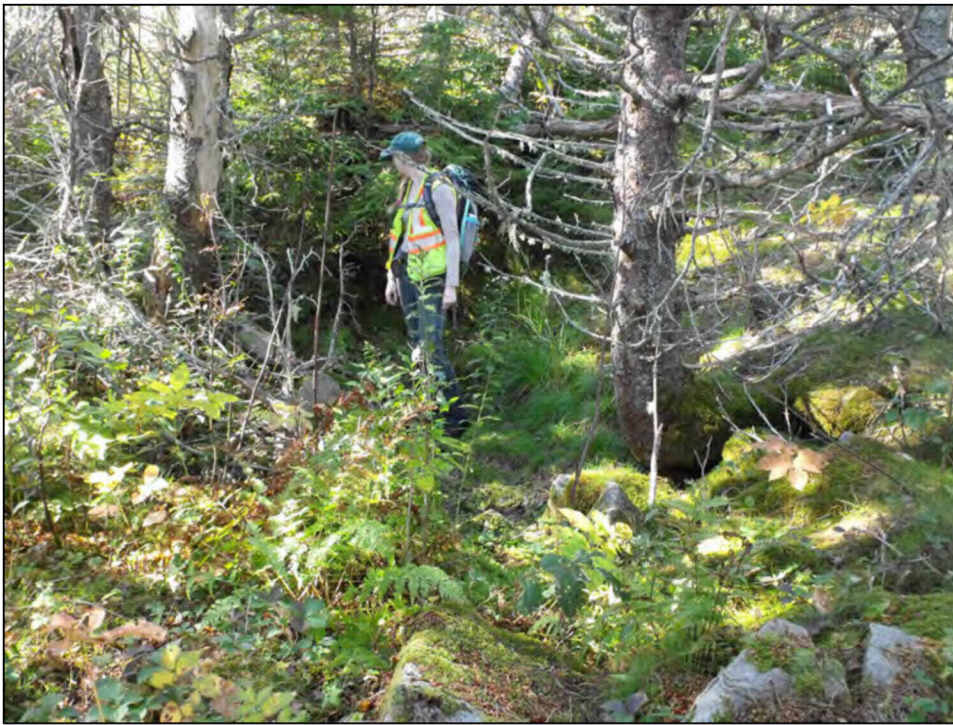
Plate 21: The Lukeman Homestead 1 foundation, looking southwest.

Upon reaching the southern edge of the study area's shoreline, the team proceeded inland onto what had previously been the historic Lukeman family grant. It was found that a thin strip of high ground lay between the shore and a low, wet area running parallel to the beach. Just inland from this, the team began to observe signs of historic agricultural activity in the form of smoother topography, with forest dominated by mature spruce rather than scrub hardwood, and several piles of stones most likely resulting from historic field clearing (20 T 645803 5023678). Within this agricultural area, the team identified two stone-lined cellars with the stone outline of a foundation around each (20 T 645784 5023703, Lukeman Homestead 1, and 20 T 645736 5023739, Lukeman Homestead 2) (Plates 21 and 22 and Figure 3.3-2), and a third cellar and foundation of the same type just beyond the former Lukeman boundary (20 T 645638
