Black Point Quarry Project
Municipality of the District of Guysborough, NS

Environmental Impact Statement

Vulcan Materials Company

February 2015

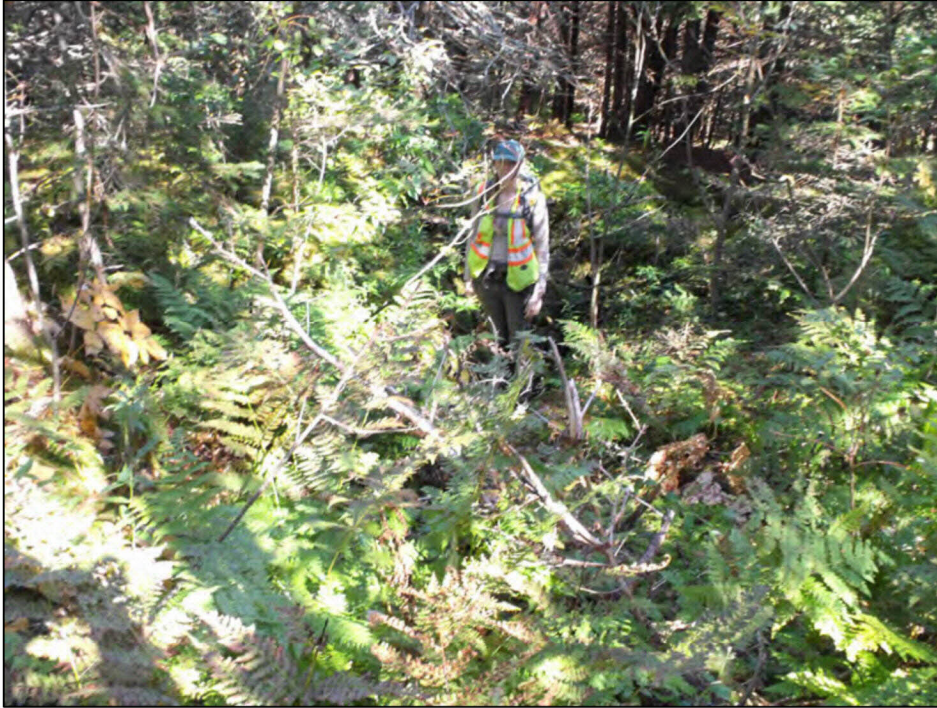
Plate 22: The Lukeman Homestead 2 foundation, looking northwest.

Upon reaching the southern edge of the study area's shoreline, the team proceeded inland onto what had previously been the historic Lukeman family grant. It was found that a thin strip of high ground lay between the shore and a low, wet area running parallel to the beach. Just inland from this, the team began to observe signs of historic agricultural activity in the form of smoother topography, with forest dominated by mature spruce rather than scrub hardwood, and several piles of stones most likely resulting from historic field clearing (20 T 645803 5023678). Within this agricultural area, the team identified two stone-lined cellars with the stone outline of a foundation around each (20 T 645784 5023703, Lukeman Homestead 1, and 20 T 645736 5023739, Lukeman Homestead 2) (Plates 21 and 22 and Figure 3.3-2), and a third cellar and foundation of the same type just beyond the former Lukeman boundary (20 T 645638

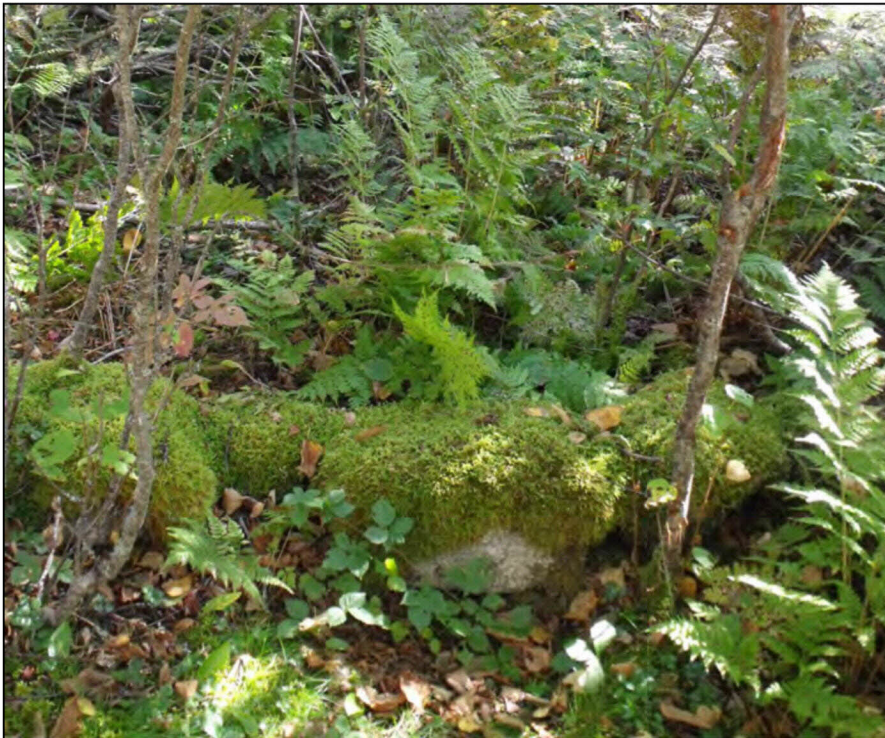
Plate 23: The third foundation to be identified, Black Point Homestead 1, looking southeast.

It is recommended that the three foundations at the east end of the property (the two on the former Lukeman property, and the third just beyond the western boundary on the former Crown parcel referred to as Black Point 1), as well as the foundation and four outbuildings on the former Fogarty property, be avoided by construction activities. It is recommended that these features be well flagged by an archaeologist and a 100 meter buffer be established around the features to ensure that their locations and boundaries are well-known and they are not disturbed during construction. It is also understood and recommended that the headland on the northwest end of the former Fogarty property that may be the location of reported historic burials will be avoided by construction. It is recommended that this area also be flagged and that the buffer zones for these resources be surveyed for future reference. It is recommended that the flagging be removed after construction so as to avoid drawing unwanted attention to these features in order to avoid looting or damage to the sites.

5023758, Black Point Homestead 1) (Plate 23). All of the foundations are positioned on small rises or headlands on the suitable ground between the ocean shore and the steeper rise to the granite barrens behind them. The rotten remains of a modern hunting blind are also visible near the second of these foundations (20 T 645720 5023748) (Plate 24).

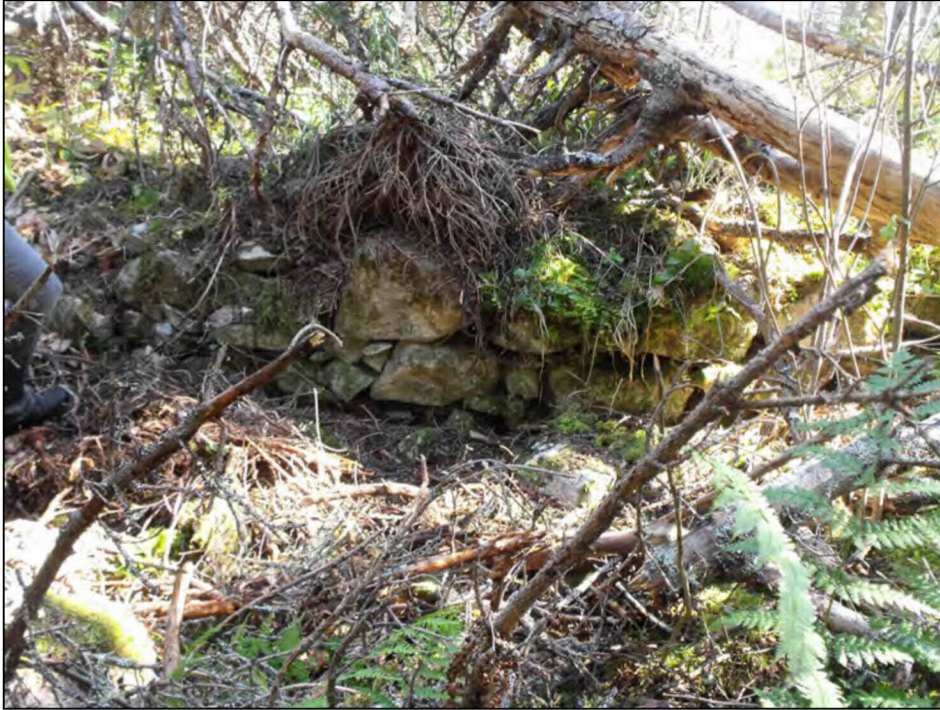
Plate 25: Intact stone within the fourth foundation, Black Point Homestead 2, looking southeast.

Mitigation of Black Point Homestead 2 and Black Point Homestead 3, which cannot be easily avoided by the development, is recommended prior to commencement of the quarry infrastructure construction. The testing phase should therefore consist of a

From here, the team proceeded northwest along an ATV trail, observing that the agricultural landscape quickly gave way to a rougher topography covered in dense undergrowth and deadfall. Nearly 400m from the previous agricultural area, stone piles and smooth topography were again noted. A fourth foundation (20 T 645230 5023976, Black Point Homestead 2) (Plate 25 and Figure 3.3-3), along with an earthen depression suggesting an outbuilding (20 T 645247 5023988) (Plate 26), were noted in the approximate center of this agricultural area, along with at least seven stone piles around the outer edges.

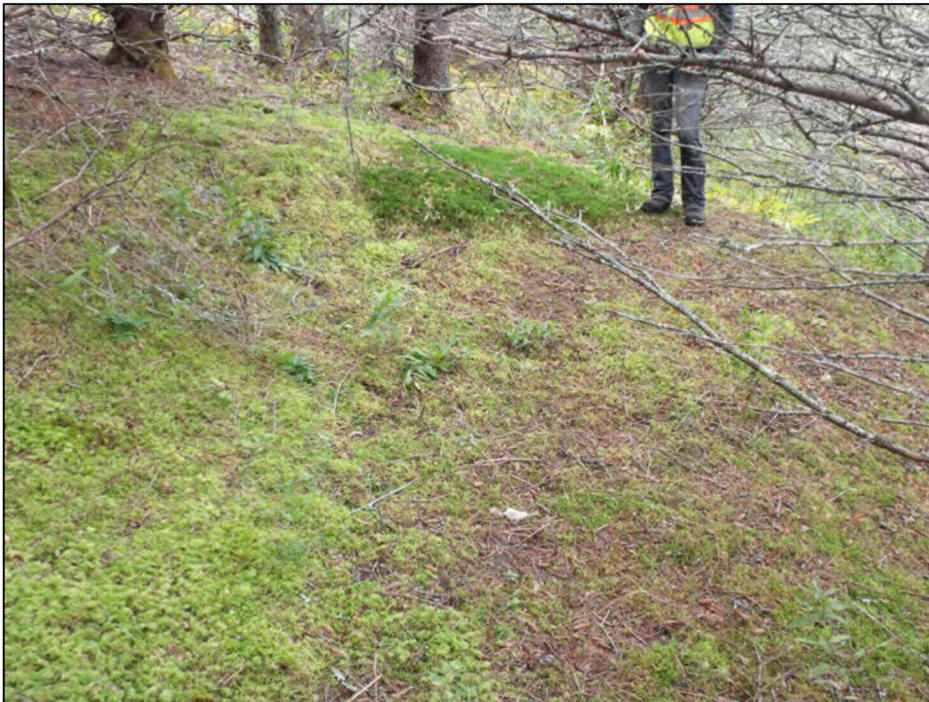
Plate 26: An earthen depression indicates a probable outbuilding near the fourth foundation, looking west.

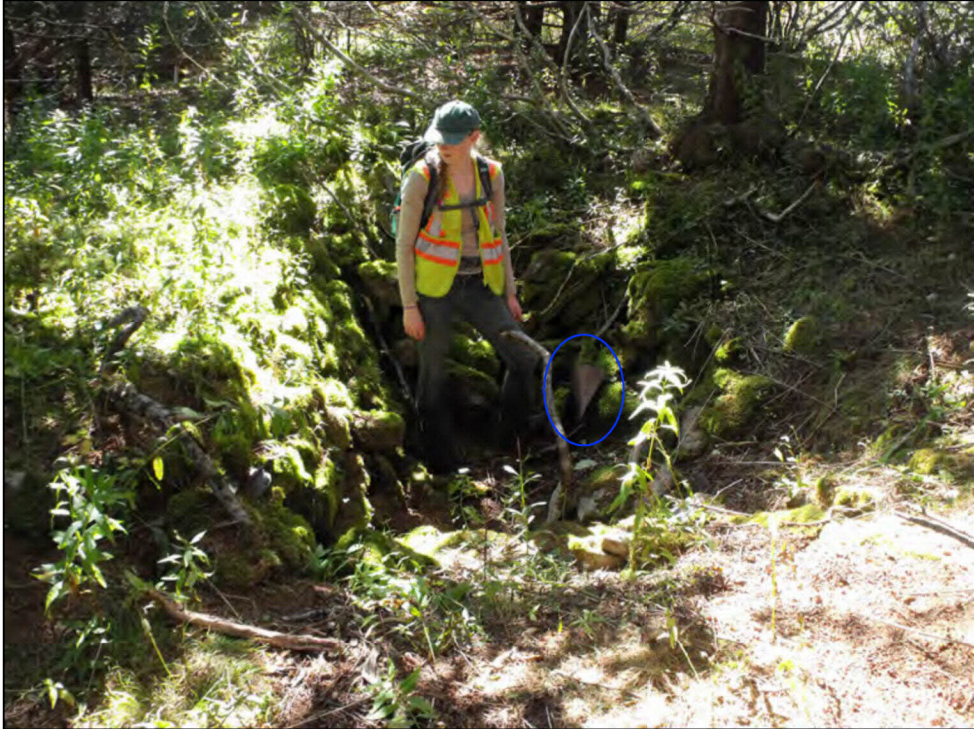
Plate 27: The fifth foundation (Black Point 3), looking south into the cellar. Note the distinct metal fragment that was also visible in Frank Fogarty's photograph (Blue) (refer back to Figure 3.2-5).

Crossing a very small stream, the team immediately encountered a mature apple tree and, proceeding onto the rising ground behind it, a fifth cellar and foundation (20 T 645219 5024030, Black Point Homestead 3) (Plate 27). Unlike the previous four foundations, which included a stone-lined cellar in the southern halves of each, this feature consists of a large rectangular foundation outlined in stone with a small cellar extending south from the middle of the southern wall. Further exploration of the surrounding area revealed that most of the agricultural landscape associated with this feature is found to the north, dotted with at least nine more stone piles.

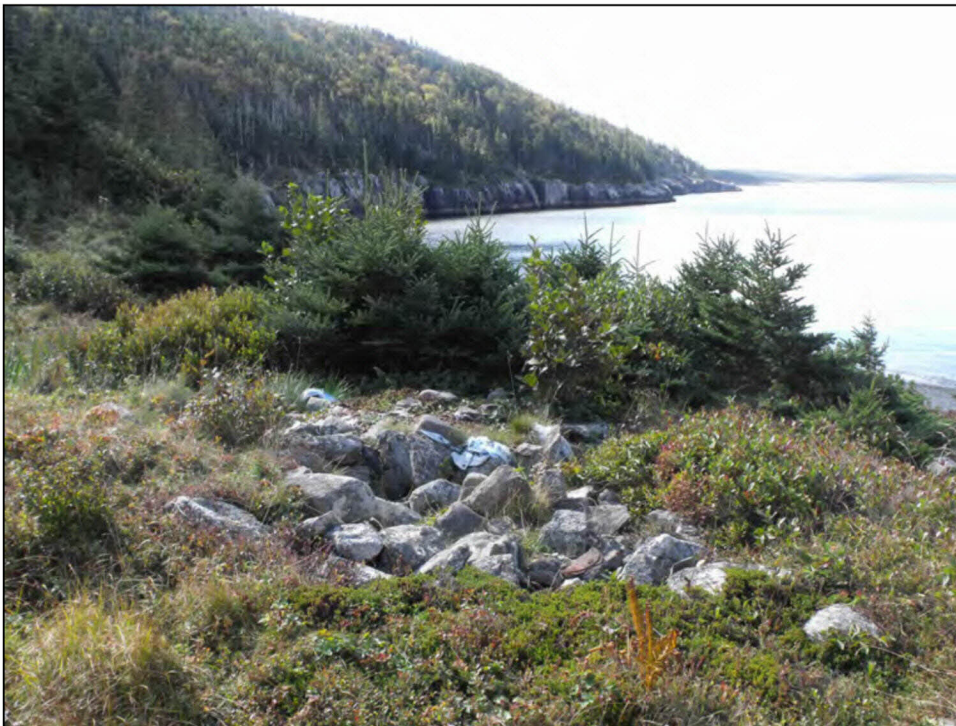
Plate 30: The first of two stone pads located in the meadow, looking west.

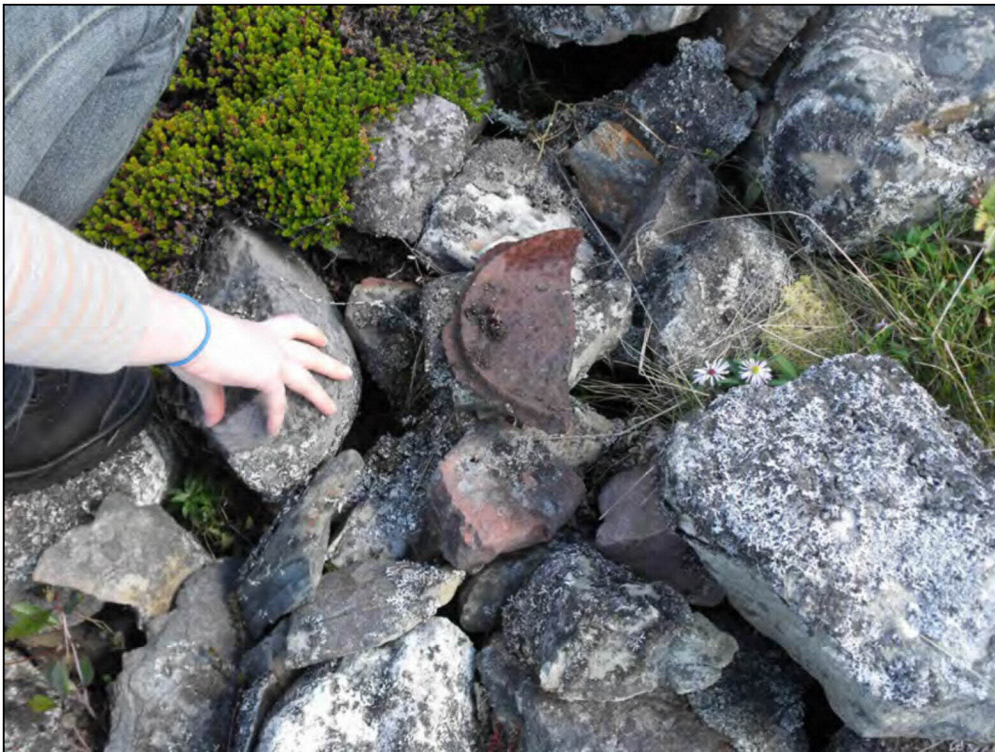
Plate 32: A cast iron stove fragment and a historic brick fragment on the first of the two stone features.

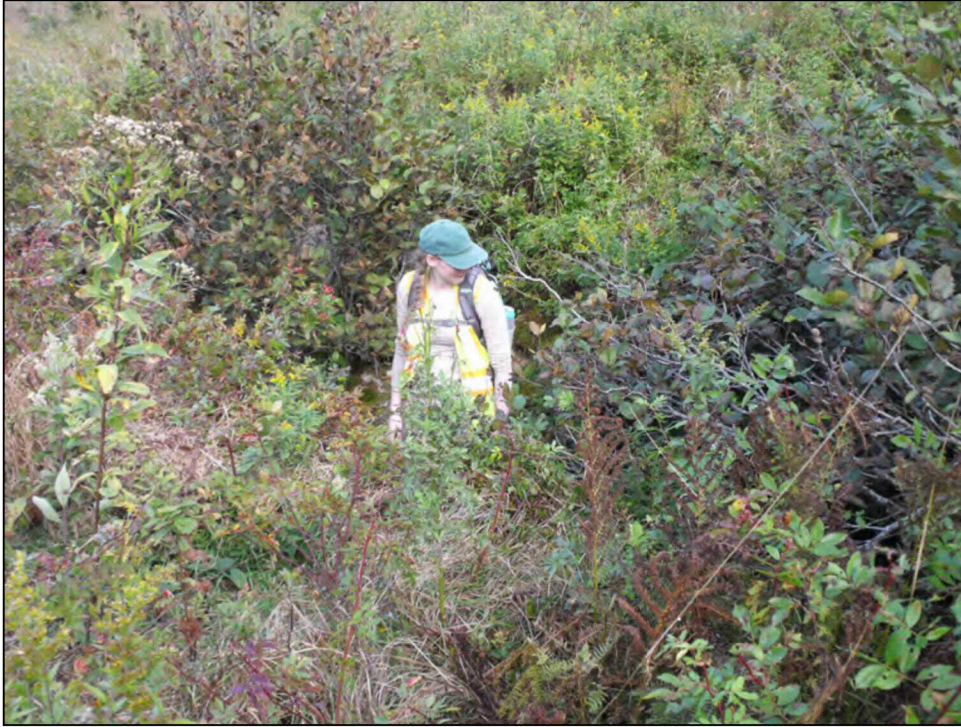
Plate 33: Courtney Glen stands inside the heavily overgrown stone cellar, looking east.

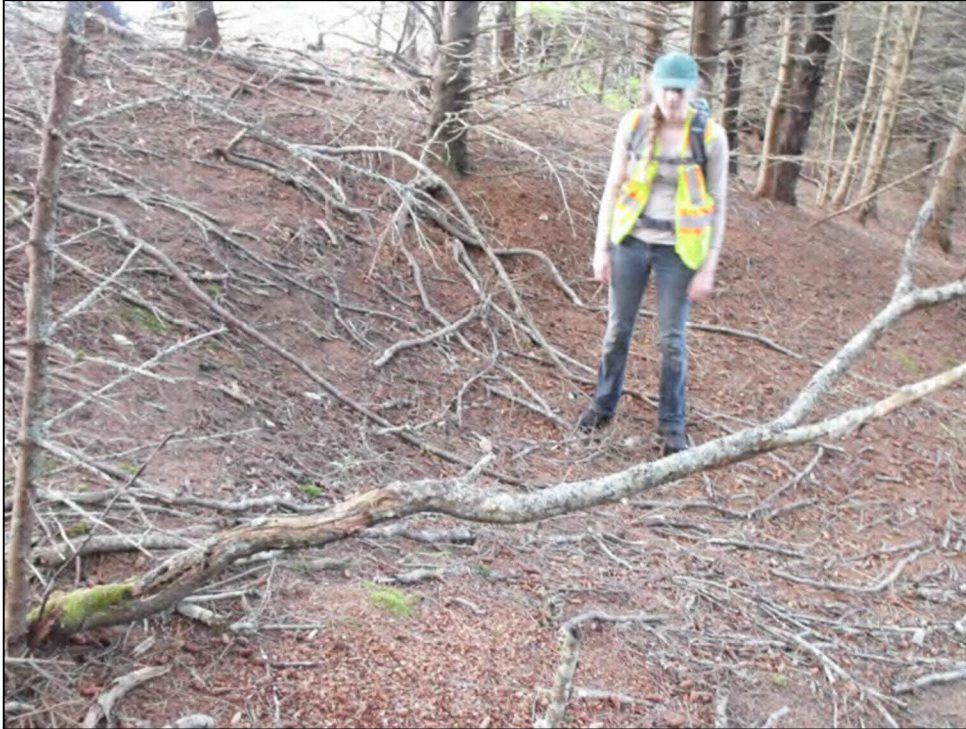
Plate 35: An earthen depression in the side of a slope suggests another outbuilding, looking northeast.

The largest of the historic features is a very deep stone-lined cellar (20 T 644417 5024095) (Plate 33), positioned within the meadow but near its edge and on higher, drier ground. The outline of this cellar is the only one of the six identified foundations that is visible on the available LiDAR data (refer back to Figure 3.3-4), most likely due to its depth and its position on more open and level ground than the other five. The surrounding soil is heavily overgrown, obscuring any foundation outline if there is one present. A rough open drain or entryway also appears to extend at least ten metres westward from the cellar. The feature is sheltered from the shoreline by a ridge of higher ground covered in spruce trees. Within the treed area, two more probable outbuildings were identified, the first a stone-lined depression (20 T 644390 5024117) (Plate 34) and the second an earthen depression built against the side of the hill (20 T 644377 5024102) (Plate 35).

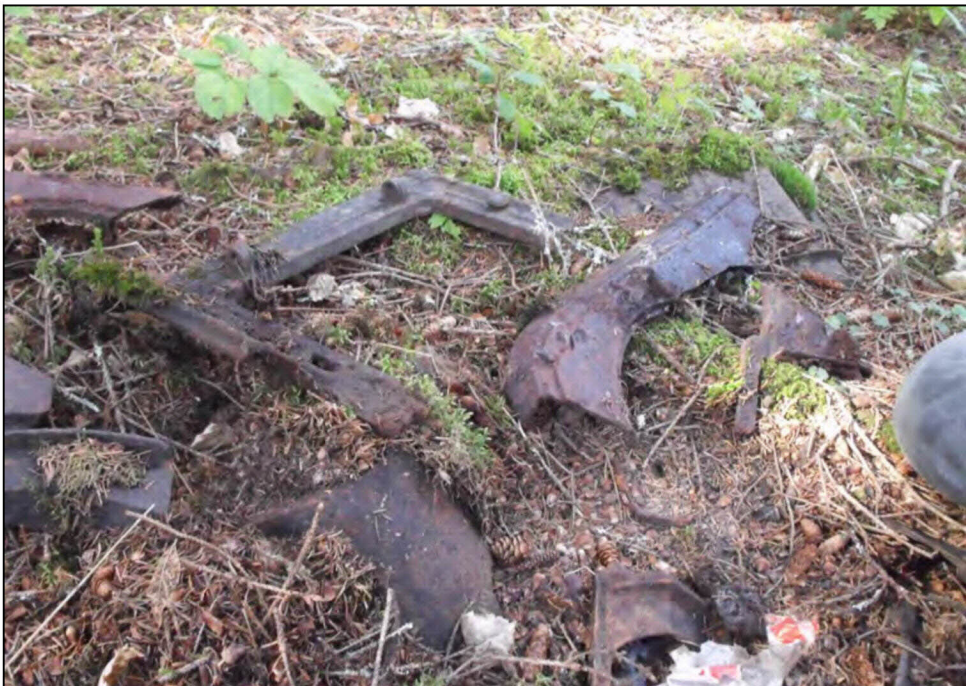
Plate 36: Fragments of a cast iron stove near the Fogarty foundation, looking west.

A cast iron cook stove in pieces is visible on the surface between the cellar and one of the outbuildings. For the most part the stove is undecorated, but it does include the foundry marks "Record F & [Co.]" (20 T 644394 5024102) (Plate 36).

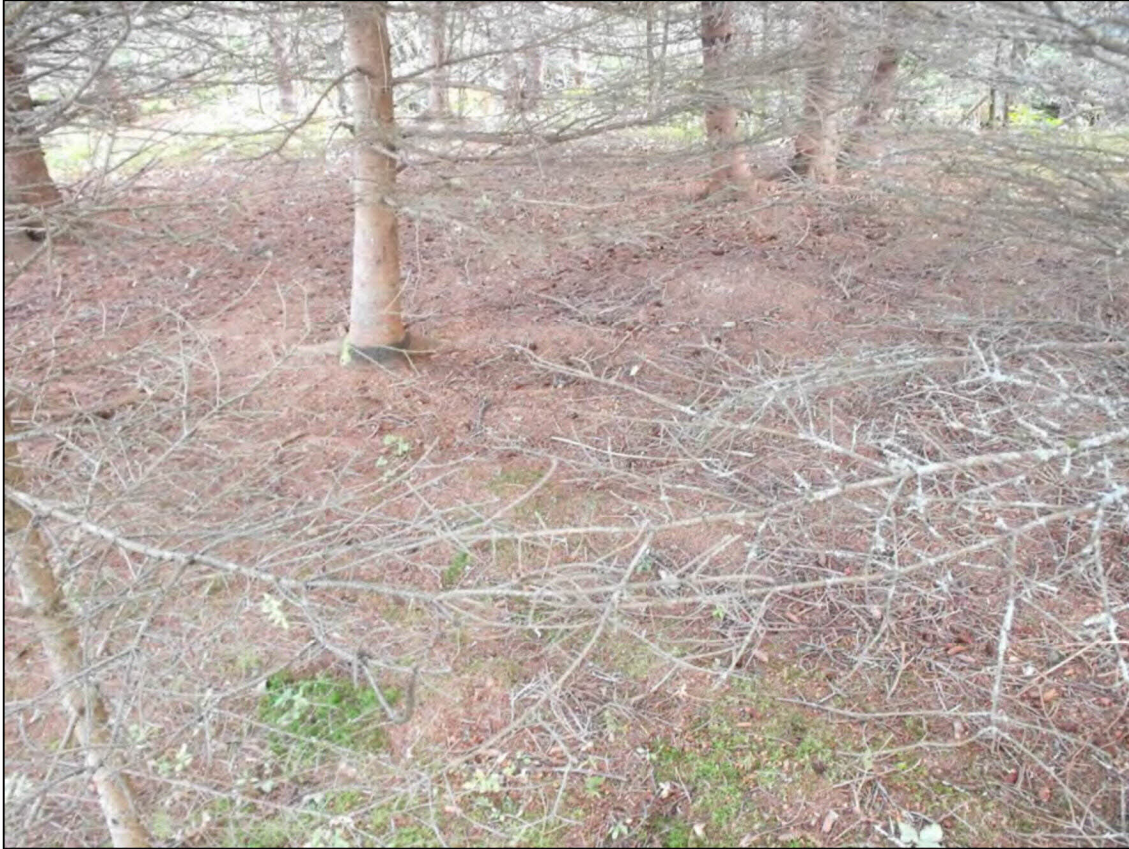
Plate 37: The smooth topography of this headland suggests it may have been an appropriate location for family burials; digging graves would have been easier than the rocky land all around, while the scenic look off towards Half Island Cove is the type of view that is found at many historic cemeteries.

Proceeding uphill along the treed divide between the meadow and the shore, the team observed that the land eventually flattens into what would have been a scenic headland before the regrowth of spruce trees covered what appears to have been smooth agricultural lands (20 T 644333 5024052) (Plate 37). While the presence of burials cannot be confirmed or refuted at this stage, it is worth noting that this location is the most suitable for historic burial of all areas observed within the study boundaries, providing a scenic view of the sea and in proximity to historic settlement by the Fogarty family. It also corresponds to the area indicated by the surviving Fogarty family's oral history as the area where burials may have occurred (refer back to Figure 3.2-6).
