# About Some Environmental Consequences of Kerch Strait Bridge Construction

Institute of Water Problems and Land Reclamation NAAS, Kyiv, Ukraine

**Keywords:** Ukraine, Kerch Strait, Tuzla Island, Sea of Azov, Satellite Data, Ecosystem Hazards

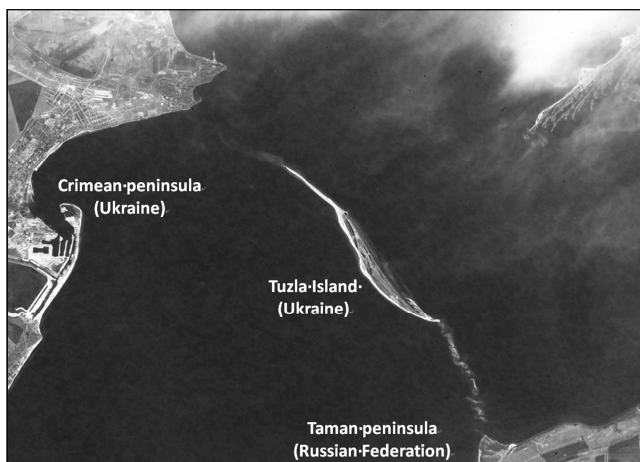
**Figure 1.** The Kerch Strait on satellite images on May 03, 1968 with the remains of the sand spit blurred by storm in 1925.

On the first known maps of the Kerch Strait, composed by Venetian sailors at the end of the XIV century, Tuzla is shown as an island. The same thing is on the map of 1559. Interestingly enough, in the next three centuries, the situation remained unchanged - on the map of 1855 Tuzla is also shown as an island. Only in the late XIX century Tuzla was connected with the Taman peninsula. The formed spit was convenient to the island's population and therefore the tendency was to maintain it. However, the strong storm that occurred on November 29, 1925 finally eroded the spit, forming a duct with a width of several hundred meters (Figure 1). Over the next decades its width has reached 4 km.

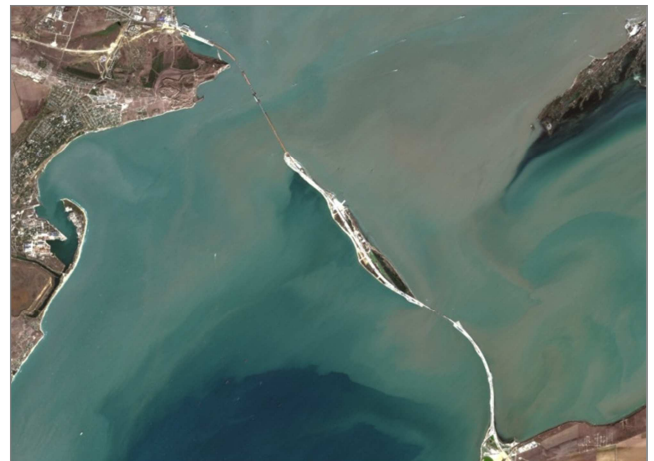
**Figure 2.** The Kerch Strait, Ukraine, Russia, satellite image in colors close to natural, Sentinel-2A, 2017. 10. 01., resolution 10 m.

After the annexation of Crimea in the spring of 2014 the Russian leadership has publicly voiced intent to build a bridge across the Kerch Strait which soon embodied in large-scale construction. The chosen route passed through the Tuzla Island and the mentioned section of the dam that was built in 2003 (Figure 2).

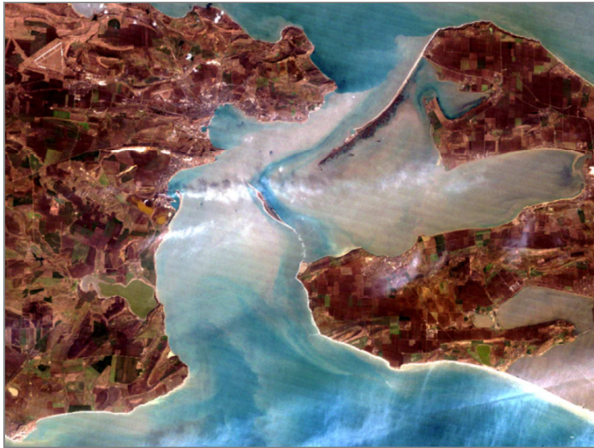
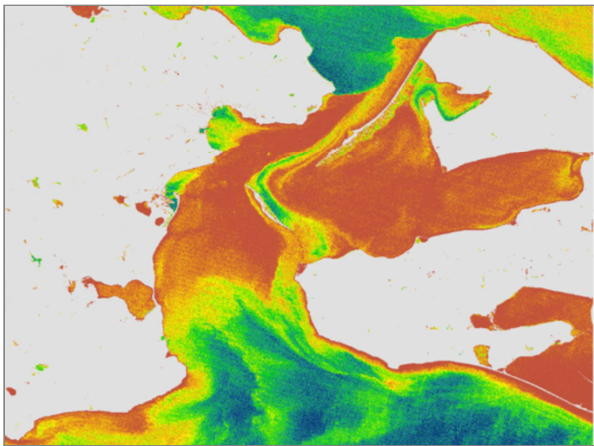
**Figure 3.** Satellite images of the Kerch Strait. Landsat 5 dated 17 Feb 1990.: a – false natural colours; b – in turbidity values.

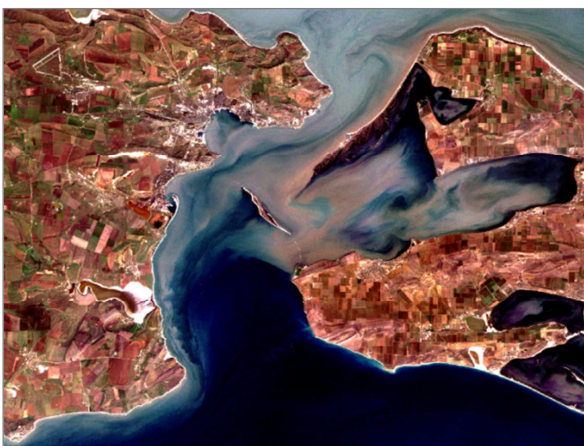
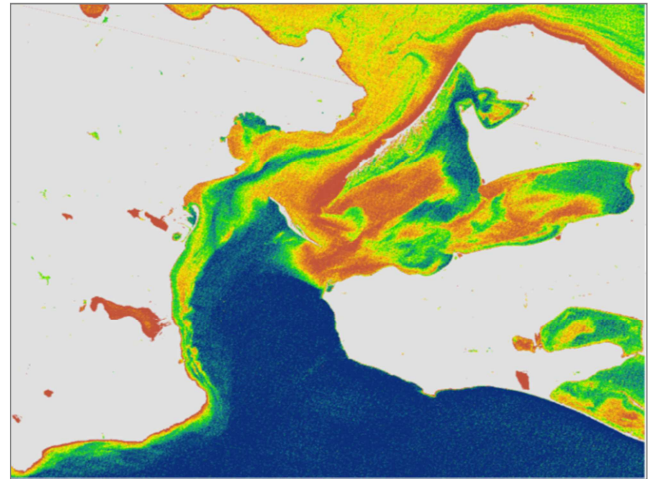
**Figure 4.** Satellite images of the Kerch Strait. Landsat 5 dated 10 Oct 1991.: a – false natural colours; b – in turbidity values.

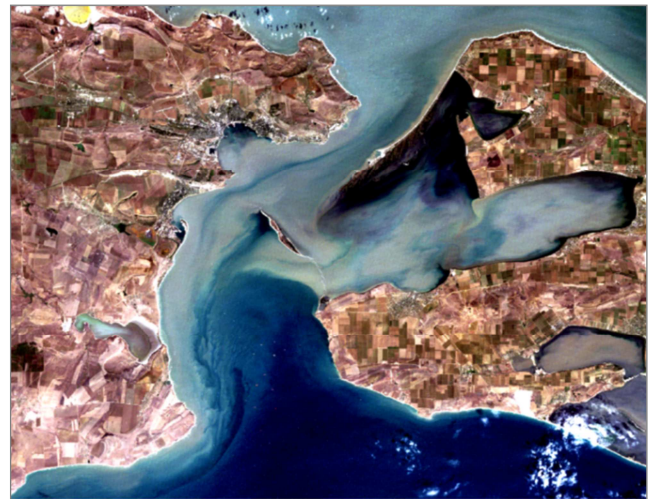
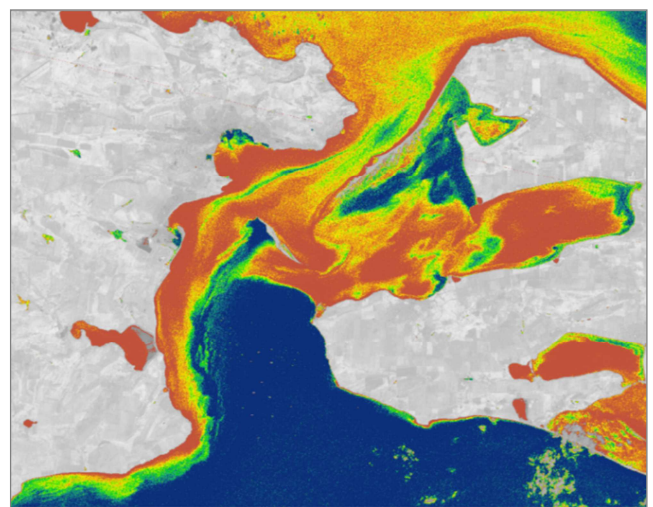
**Figure 5.** Satellite images of the Kerch Strait. Landsat 5 dated 19 Sep 2001.: a – false natural colors; b – in turbidity values.

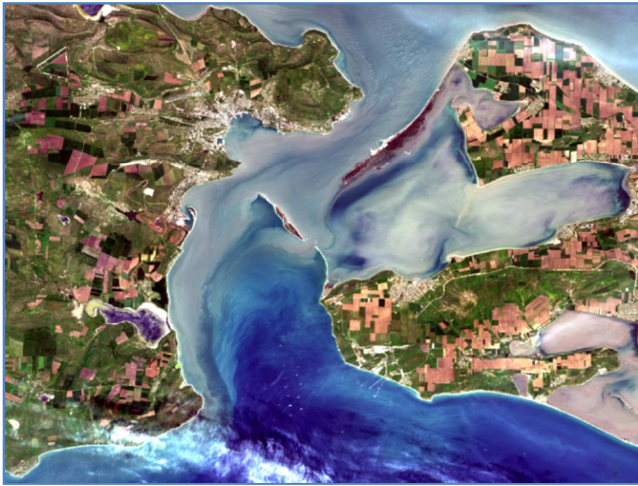
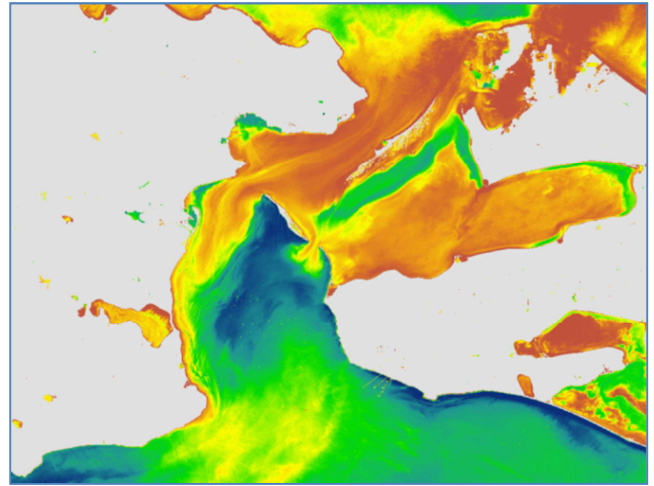
**Figure 7.** Satellite images of the Kerch Strait. Landsat 8 dated 06 Jun 2015: a - false natural colors, b - in turbidity values.

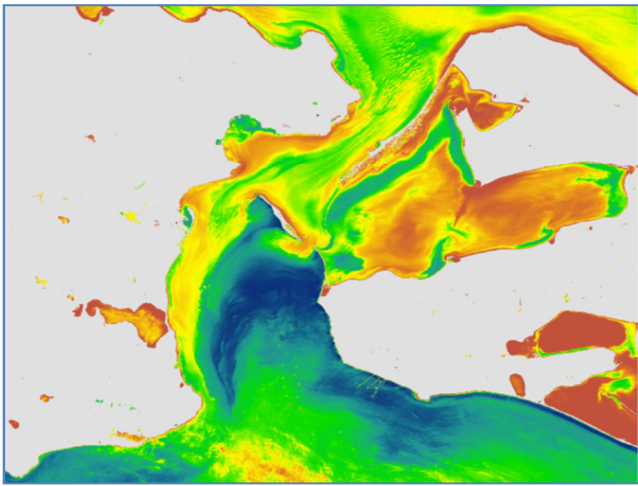
**Figure 6.** Satellite images of the Kerch Strait. Landsat 8 dated 21 May 2015: a - false natural colors, b - in turbidity values.

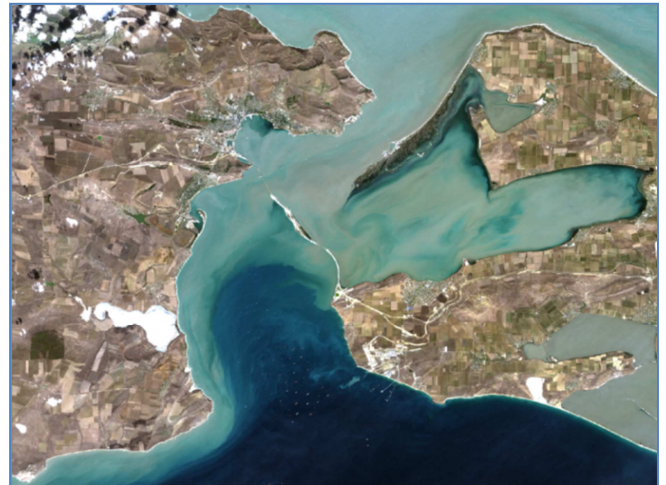
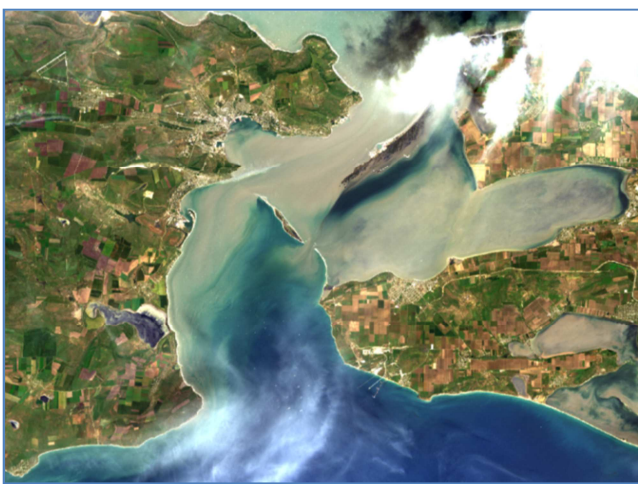
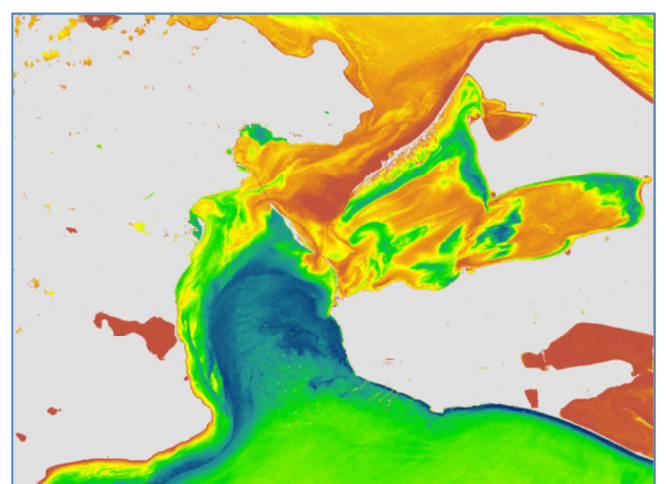
**Figure 8.** Satellite images of the Kerch Strait. Landsat 8 dated 01 Oct 2017: a - false natural colors, b - in turbidity values.

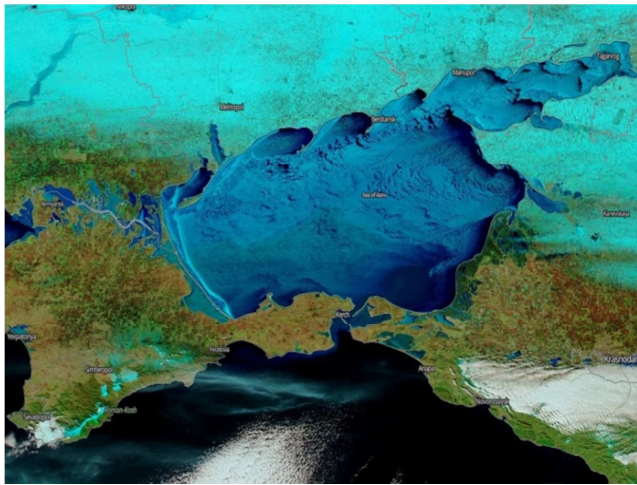
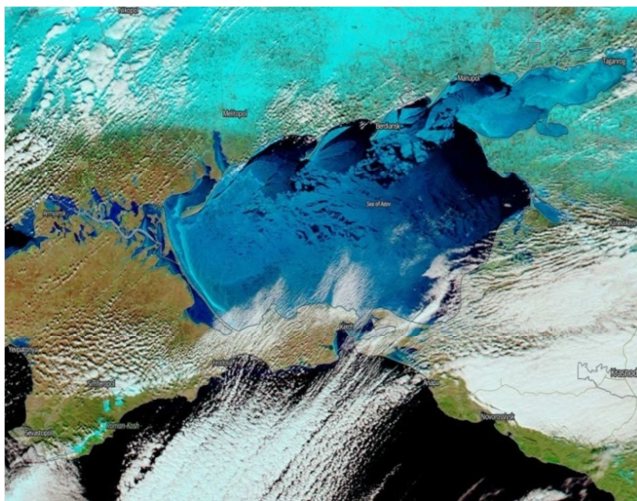
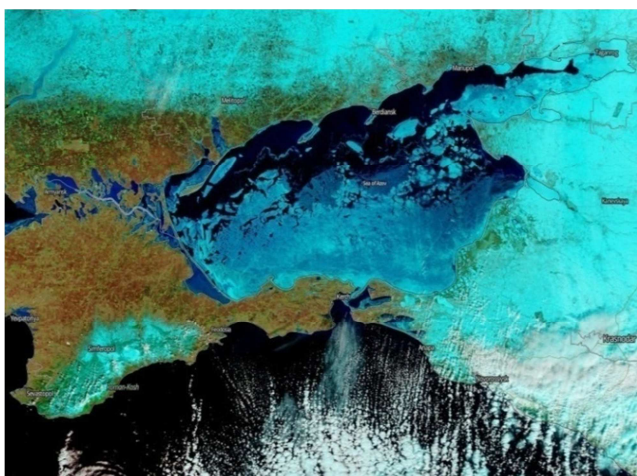
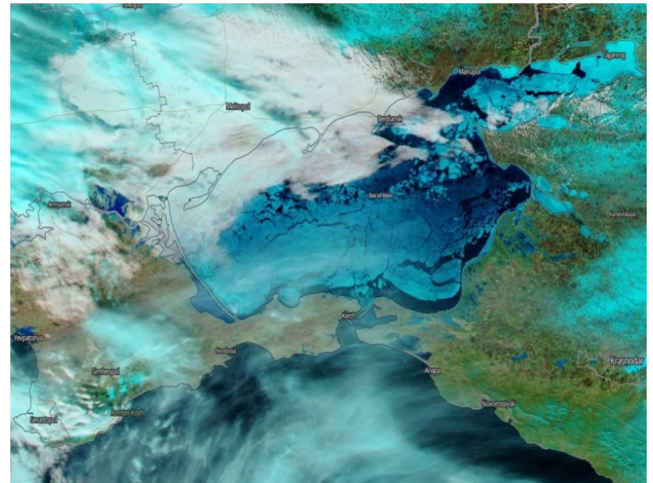
**Figure 9.** Ice cover formation and drift in the Sea of Azov in February 2017.

days of February 2017, the withdrawal of ice from the Sea of Azov began, and during the next few days almost all of the northern part of the Kerch Strait was covered with ice (Figure 9, 10).

It is significant to mention, that the weather conditions for the above dates corresponded to the usual conditions. The average air temperature in Kerch (more precisely at the hydrometeorological station Opasne) in January 2017 was minus 0.4°C, during February 1-12, 2017 – minus 1.1°C. Obviously, it is under the lower average air temperature, which is often observed here. The ice situation will be even more stringent.

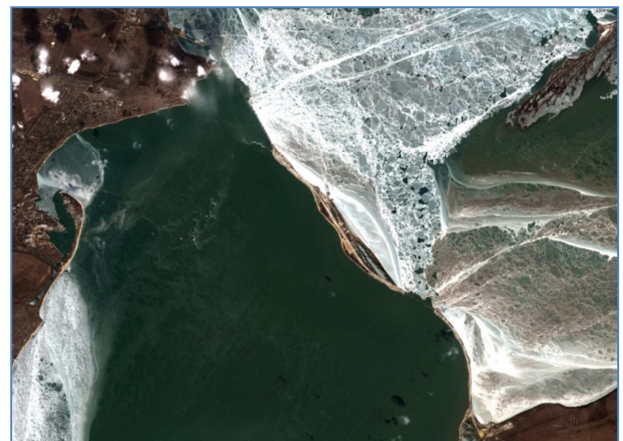
**Figure 10.** Ice spreading in the Kerch Strait according to the satellite Sentinel 2a dated 13 Feb 2017.

The daily satellite monitoring of the Kerch Strait in February 2017 made it possible to identify the peculiarities of the formation and drift of the ice cover in Sea of Azov through the Strait. According to the satellite images, it was found that the ice actually don't pass between bridge pillars even when the strong north-east wind blows, including the widest navigable passage.

Working bridge constructed across the Kerch Strait caused a stop of the ice drift from the Sea of Azov to Black Sea and caused an ice blocking in the strait. Although the ice is thin (5-10 cm), there is a large amount of it in Sea of Azov with no way out so the hummock formation began.

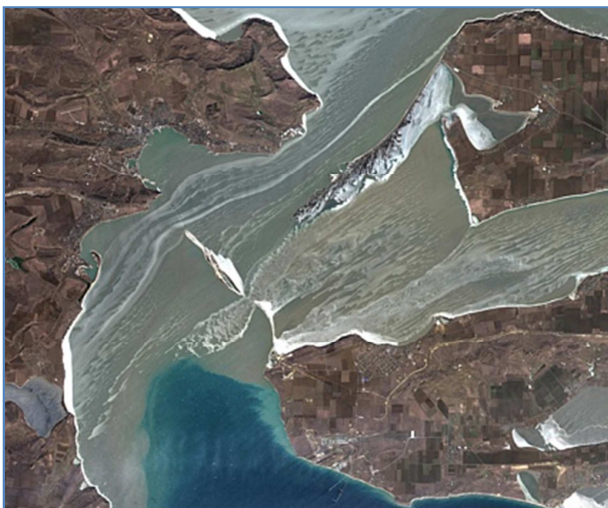
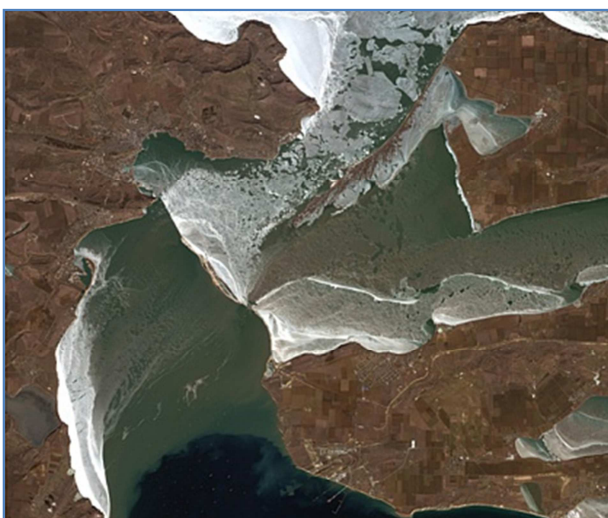
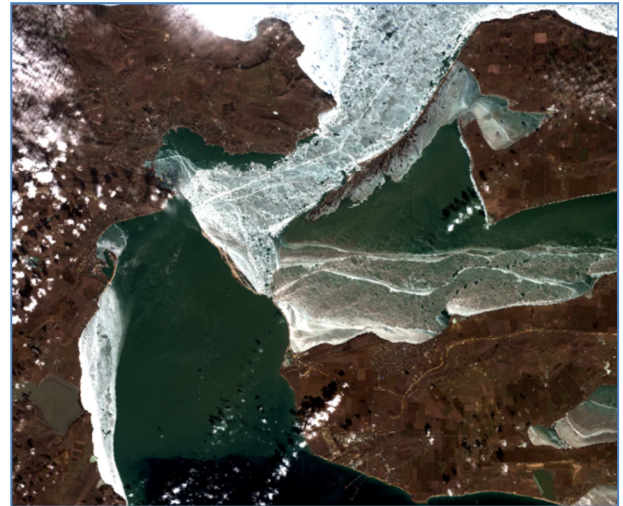
**Figure 11.** The Kerch Strait Bridge became a barrier in the way of ice drifting under the influence of the wind from the Sea of Azov to the Black Sea: a – Satellite image SPOT 7 (AIRBUS Defence & Space) dated 09 Feb 2017; b – Satellite image SPOT 7 (AIRBUS Defence & Space) dated 11 Feb 2017; c – Satellite image Sentinel 2A (ESA) dated 13 Feb 2017.

We make a point of the fact that the advection of ice in the Kerch Strait from the Sea of Azov is an ordinary situation. The analysis of satellite data collected in this area during the current century and accumulated in the NASA and USGS archives has shown that similar situations emerged, in particular, in January-February 2003, 2006, 2008, 2012, and 2014. At the same time, the ice situation in the Sea of Azov and the ice drift to the Kerch Strait may be much more significant than the situation observed in February 2017 (Figure 11). For example, Figure 12 shows the situation observed in the region on 2-3 February 2014.

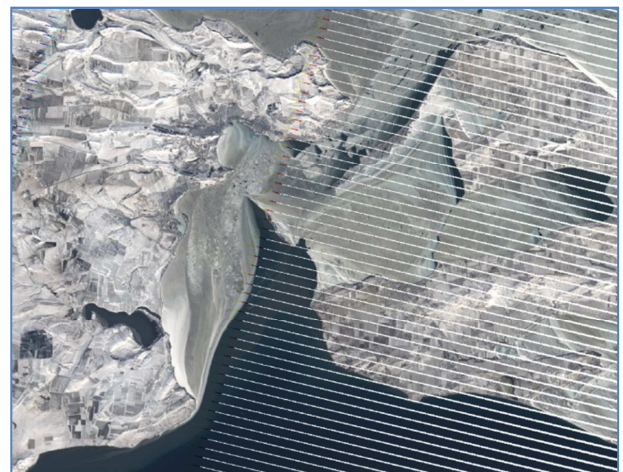
**Figure 12.** Ice situation in the Azov and Black Seas, ice passing to the Kerch Strait according to satellite image from Landsat 7 dated 03 Feb 2014.
