**Commission for the Protection
of the Black Sea Against Pollution**

**Oil spill accident in the Kerch Strait
in November 2007**

**Moscow
2011**

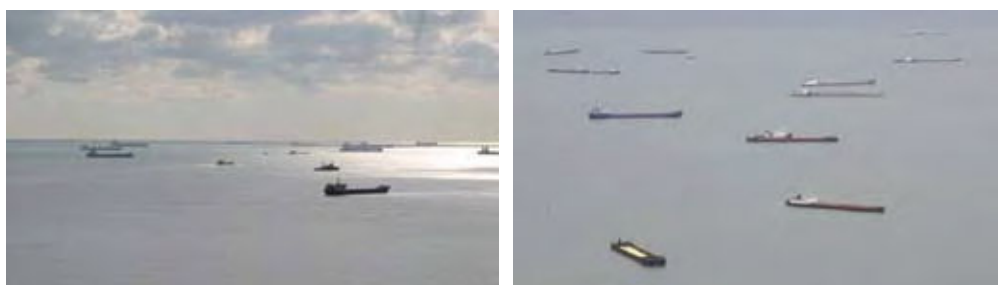
Photo: Berths and a queue of ships at anchorage in the southern part of the Kerch Strait (Booklet, 2009).

² Transshipment areas (Fig. 2) are located in the shallow waters of the Kerch Strait Southern part without a natural shelter from storms. When ships lie at anchor in the Southern area of the Kerch Strait, as well as at the berth with the coordinates 45°06'N, 36°33'E, they are positioned about 15 miles away from the place of refuge (the Northern area of the Kerch Strait which is well protected from the Southern waves by the Tuzla Island and Chushka Spit, being considered as the place of refuge). The berths in the Southern area of the Kerch Strait do not provide protection from the waves coming from the hazardous Southern directions especially.

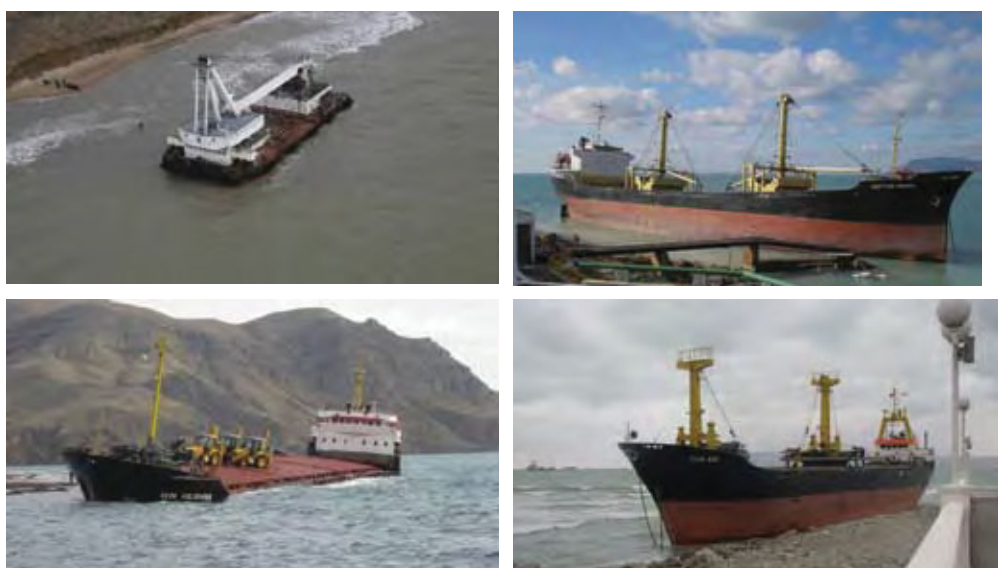
Photo: The *Sevastopolets* floating crane in the Kerch Strait, the *Captain Ismael* dry cargo ship stranded in Novorossiysk, the *Vera Voloshina* cargo ship aground in Crimea and *Ziya Koc* dry cargo ship in Novorossiysk, photo re-drawn from Booklet, 2009, and by *Alexander Kuznetsov*.

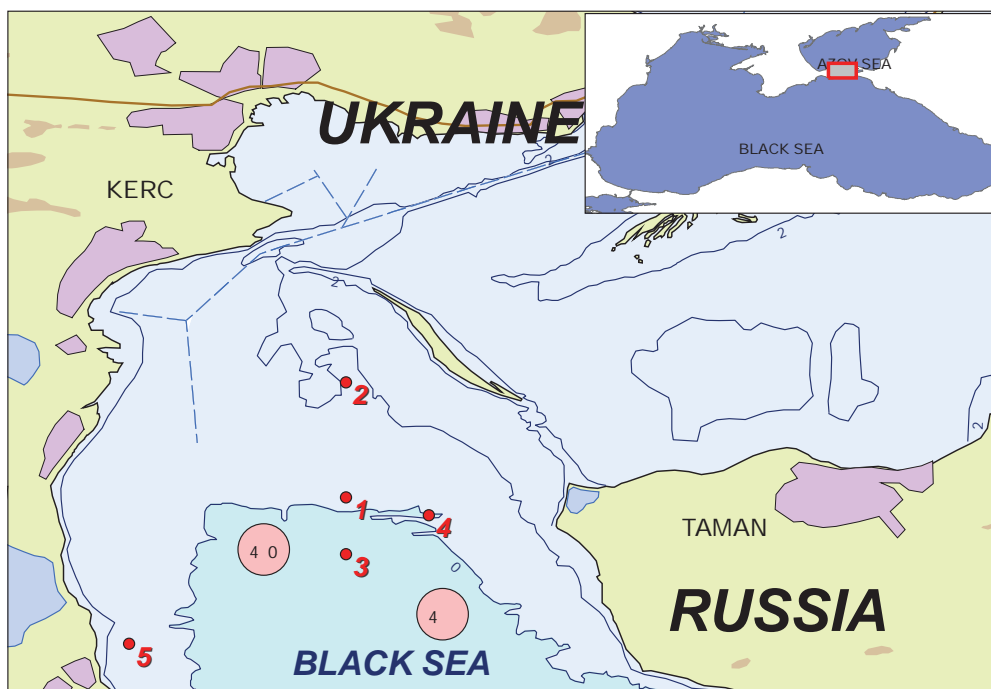
Fig. 2. Map of the areas where the ships sank in the Kerch Strait on 11 November 2007: the Volgoneft-139 tanker bow (point 1) and stern (point 2; 45°15'5 N and 36°31'8 E), Volgoneft-123 (3; 45°11'6 N and 36°31'8 E), Nahichevan (4; 45°12'0 N and 36°33'3 E) and Kovel (5; 45°09'1 N and 36°26'6 E). Transshipment areas Nos 450 and 451 are marked in red.

The *Vologoneft-139* motor tanker and the *Volnogorsk*, *Nahichevan* and *Kovel* dry-cargo motor vessels anchored in the Kerch Strait were virtually torn apart by the storm. The *Vologoneft-139* boat broke into-two and its bow sank in vicinity of the main ship channel of the Strait at the 10 m depth. The stern section drifted by wind to north and touch the ground at 45°15'5 N and 36°31'8 E. From this tanker leaked about 1300 tons of heavy fuel⁵, and it happened approximately five km to the West from the Tuzla Spit (Fig. 2). An immediate attempt to prevent oil from leaking from the wreck by using

The other motor vessels of Volnogorsk (loaded with 2437 t of granulated sulfur), Nahichevan (2366 t) and Kovel (1923 t) did not sink immediately, but drifted towards the coast of Ukraine to the South from the Tuzla Island. It was later reported that the sulfur granulates discharged to the sea floor had been leaked from the Kovel motor vessel. The m/v Volnogorsk sank at 45°11'6 N and 36°31'8 E at the depth of 11 m. All the crewmembers (8 persons) left on the life raft. The Neptunia sea tug (Ukraine flagged) was sent to the life raft. The Nahichevan motor vessel sank at 45°12'0 N and 36°33'3 E; Kovel sank at 45°09'1 N and 36°26'6 E (Fig. 2).

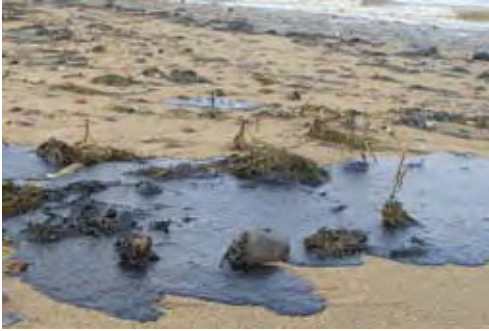
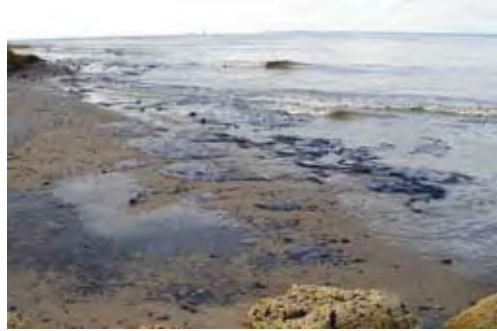
Photo: November 12, 2007, oil patches on the Tuzla Spit, <http://www.flickr.com/photos/>.

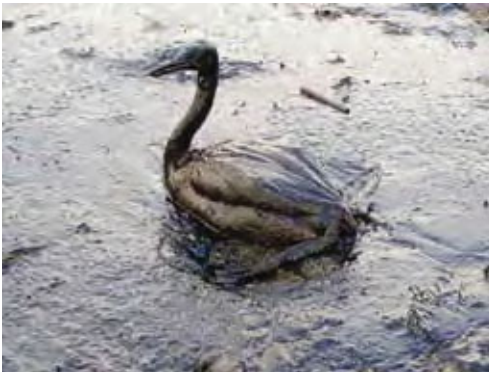
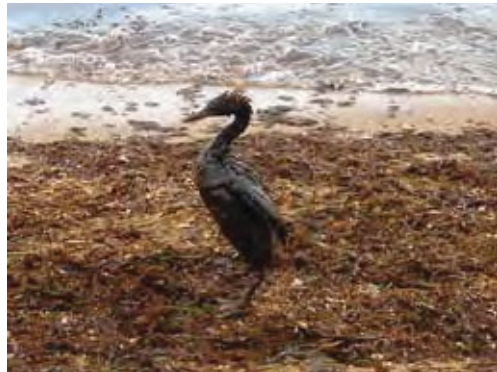
Photos: A birds stained with fuel oil sits at the shore near Russia's port Caucasus (published by Reuters: Mr. Alexander Natruskin), photo of Igor Golubenkov (NGO: Saving Taman, <http://www.flickr.com/photos/>).

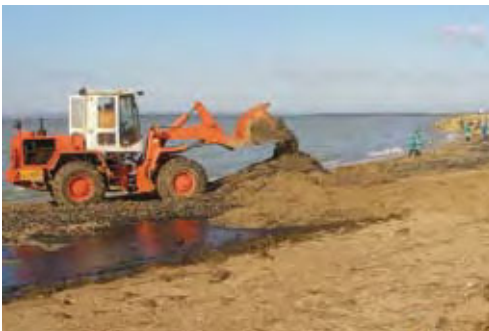
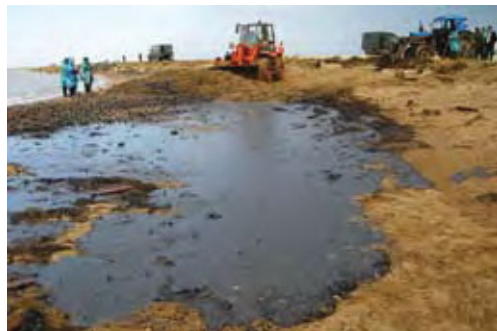
Photo: Techniques were used for the clean-up operations on the coast, by Igor Golubenkov (NGO: Saving Taman), November 12, 2007, on Tuzla Spit, <http://www.flickr.com/photos/>.

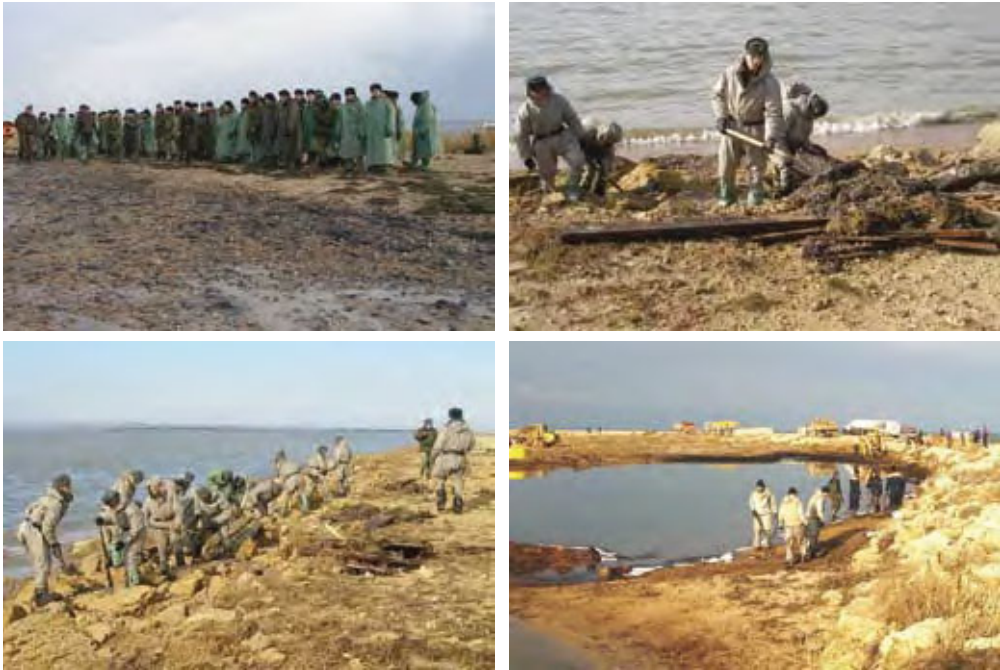
Photo: Military forces and volunteers engaged in clean-up operations on the coast, by Igor Golubenkov (NGO: Saving Taman), November 12, 2007, on Tuzla Spit, <http://www.flickr.com/photos/>.
